# The Inspector

Park Model Lane, Apache Junction, 85120  
Inspection prepared for: John and Mary Another sample  
Date of Inspection: 6/28/2022 Time: 8:30am - 3:15pm  
Age of Home: Built in 1989 Size: 399 S.F.  
Weather: Sunny, 100's. Rain in past 72 hours.  
Front of House Faces: South  
Client/Agent Present at Inspection? No  
House Occupied? Yes

## Inspection Summary

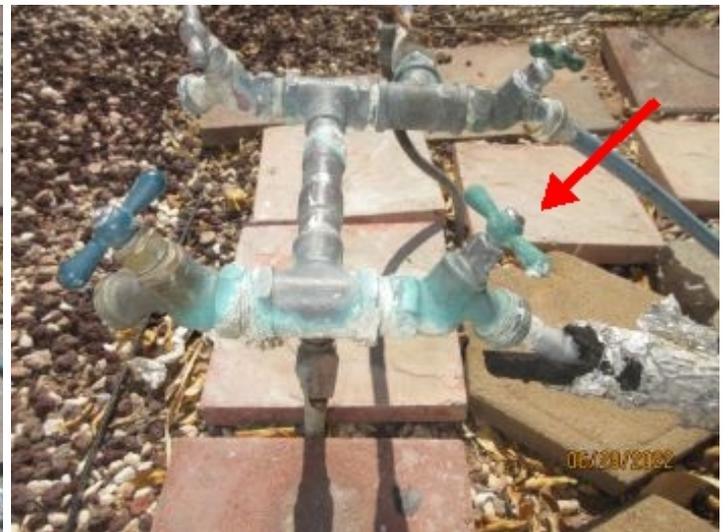
Main water shutoff for house located on northeast side of house.

Main water shutoff for house located on northeast corner of house.

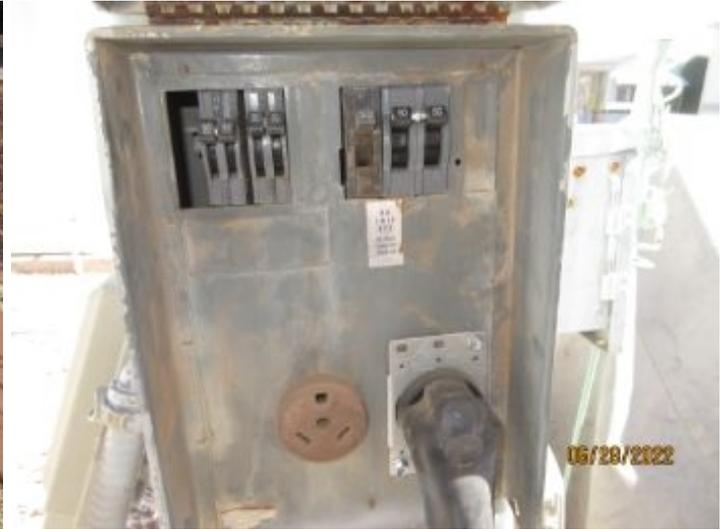
Main electric panel located on east side of house

Main service shutoff located at northeast corner of house on metal pedestal.

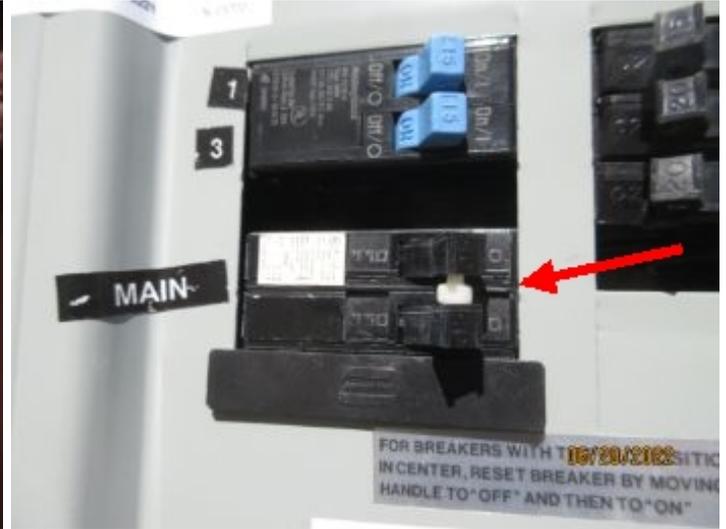
Main service shutoff located at northeast corner of house on metal pedestal.

Main electric panel located on east side of house

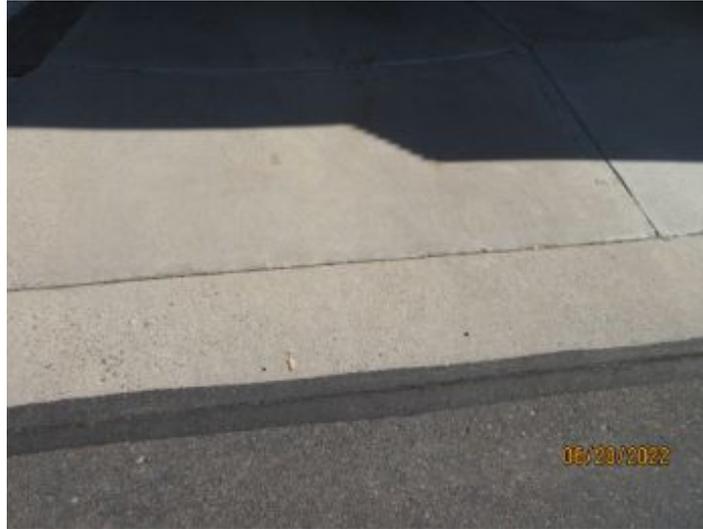
Concrete driveway appeared to be in good condition with common cracks noted.

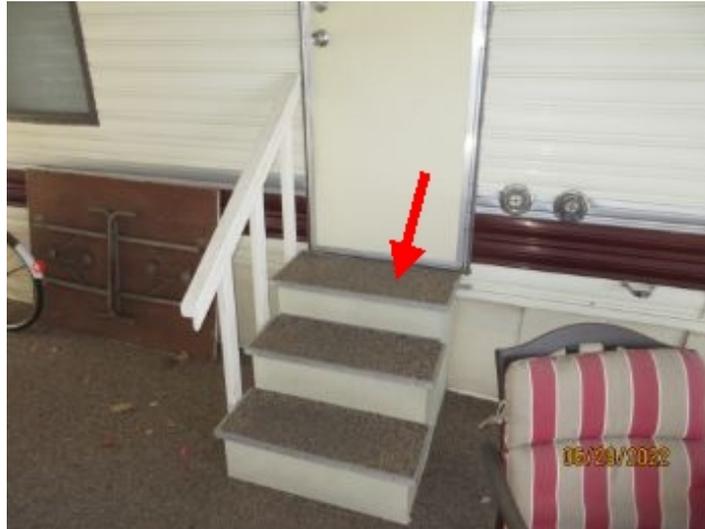
Recommend reconfiguring the top landing at the stairs at the north exterior door. Entry doors should have a landing 36 inches deep and the width of the door opening, recommend review and repair by qualified contractor.

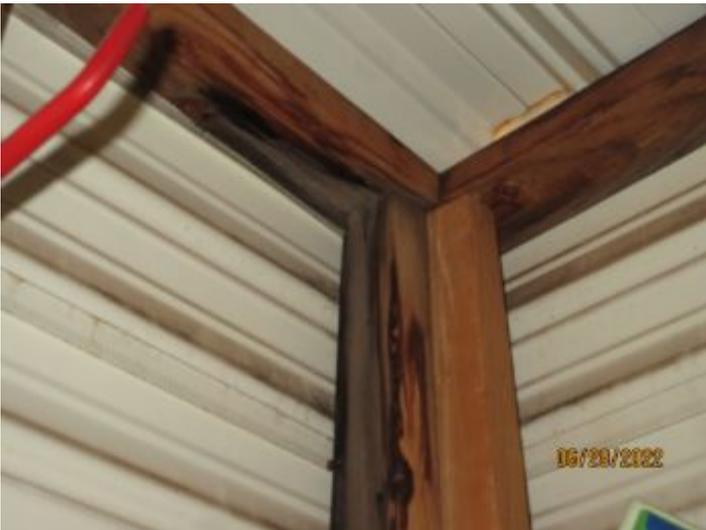
Aluminum siding

Water stains/damage noted inside shed

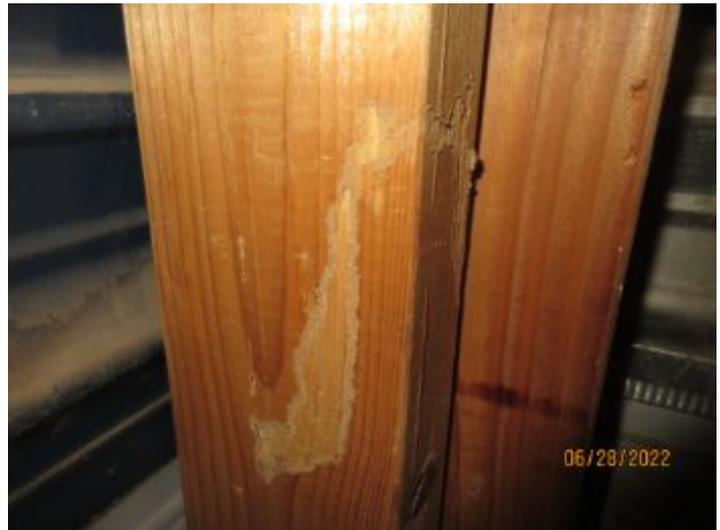
Evidence of termite activity noted in shed.

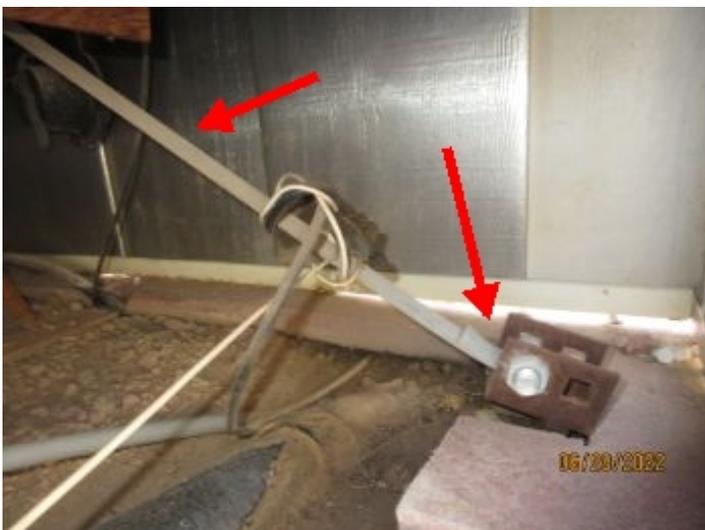
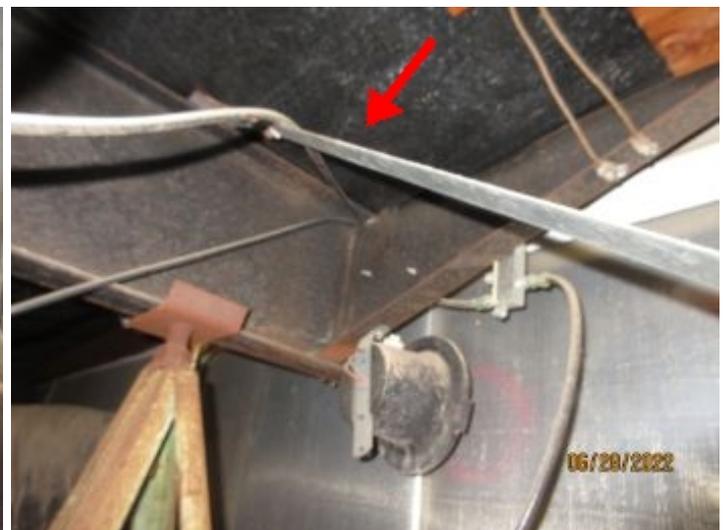
**Cold air (77 degrees) was exiting from the the A/C ductwork under the home at the time of inspection. It appears that air conditioning ductwork is blowing cold air into the crawlspace. Recommend further review/repair by a qualified HVAC contractor.**

Anchor tie-down straps appeared to be installed under home Anchor tie-down straps appeared to be installed under home

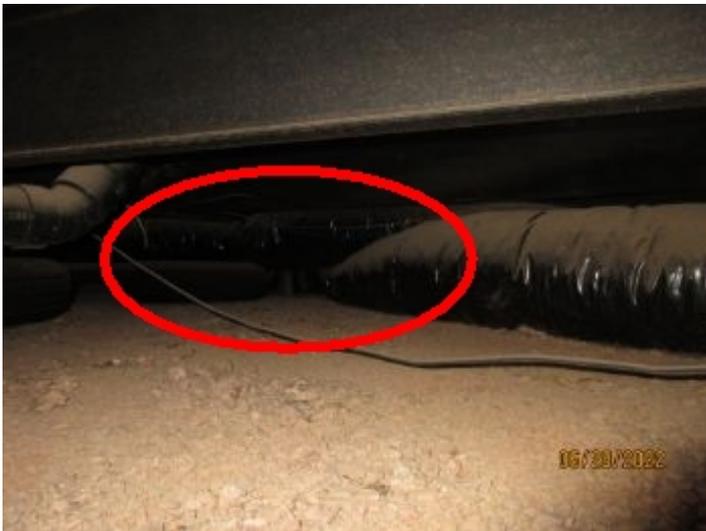
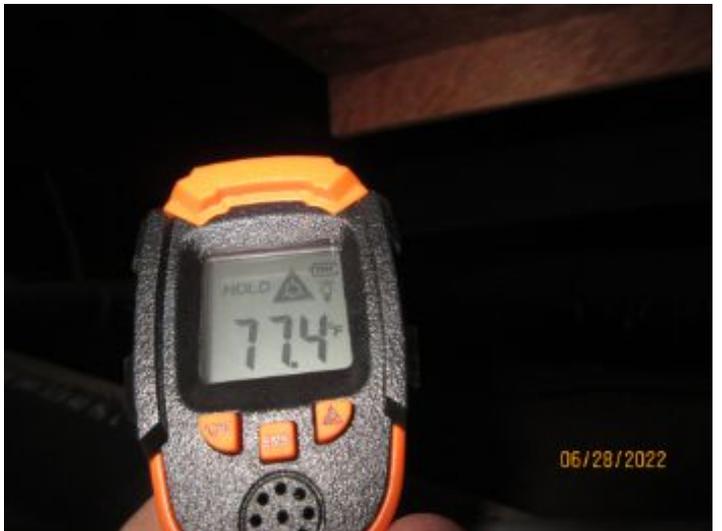
Metal jacks were tight against frame in the areas that I could see.

Cold air (76 degrees) was exiting from the the A/C ductwork under the home at the time of inspection. It appears that air conditioning ductwork is blowing cold air into the crawlspace. Recommend further review/repair by a qualified HVAC contractor.

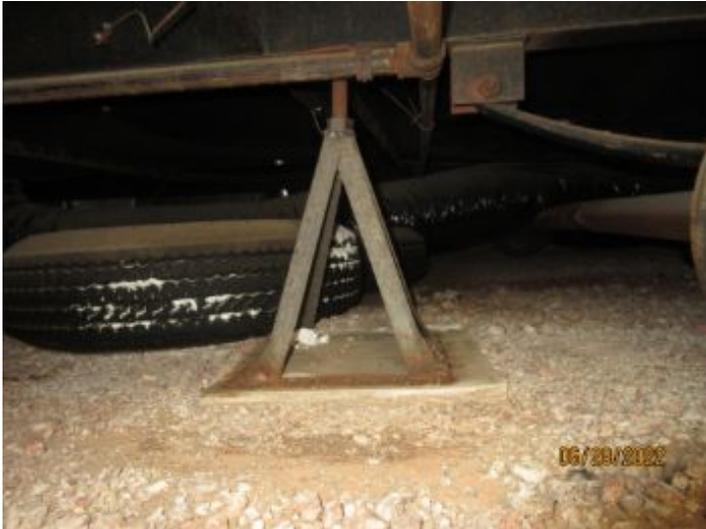
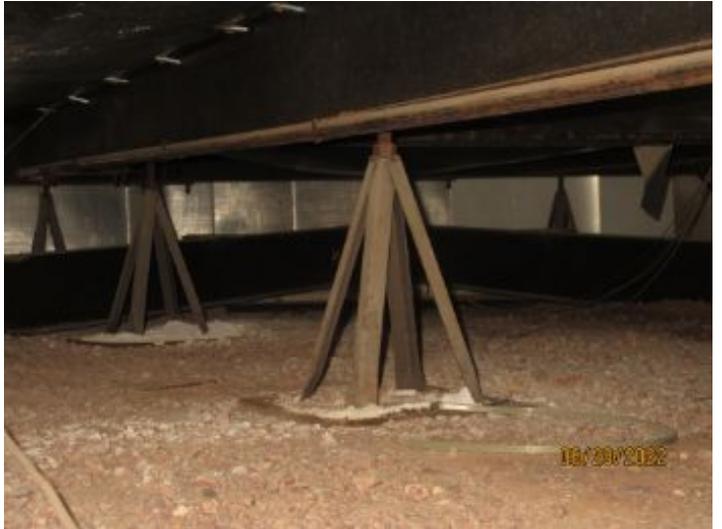
Cold air (77 degrees) was exiting from the the A/C ductwork under the home at the time of inspection. It appears that air conditioning ductwork is blowing cold air into the crawlspace. Recommend further review/repair by a qualified HVAC contractor.

Metal jacks were tight against frame in the areas that I could see.

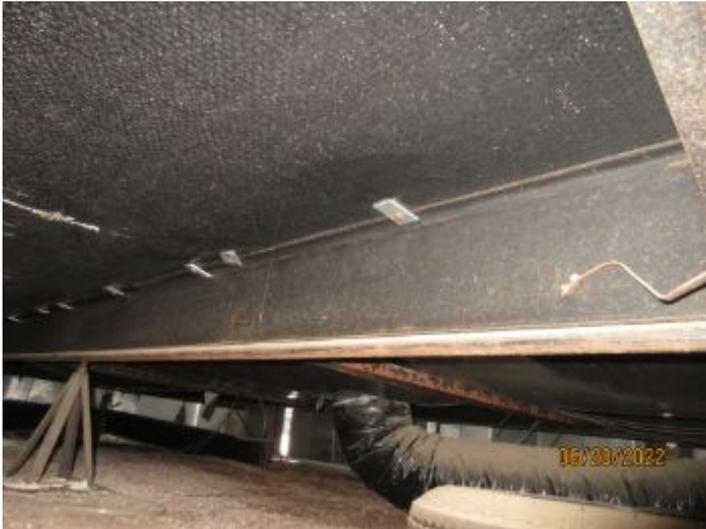
Metal jacks were tight against frame in the areas that I could see.

The metal beams appear to be in good condition

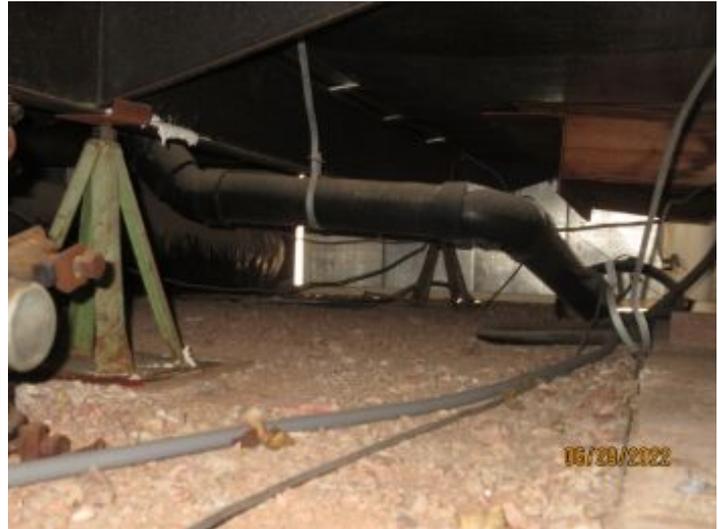
No evidence of plumbing leaks noted in the crawl space in the areas I could see at time of inspection

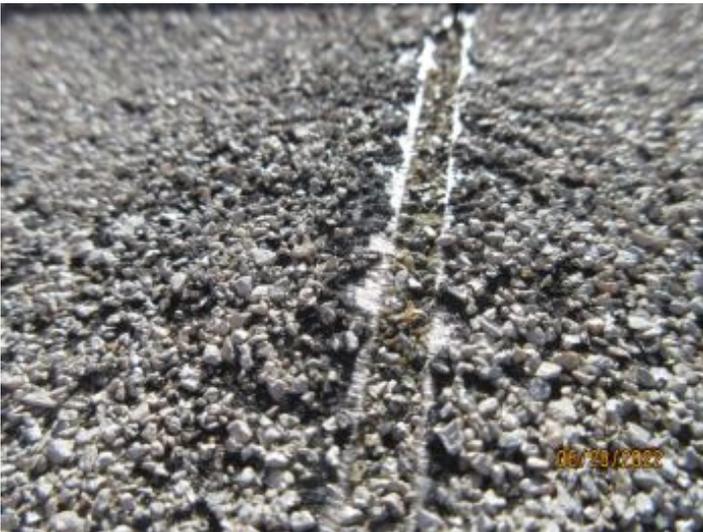
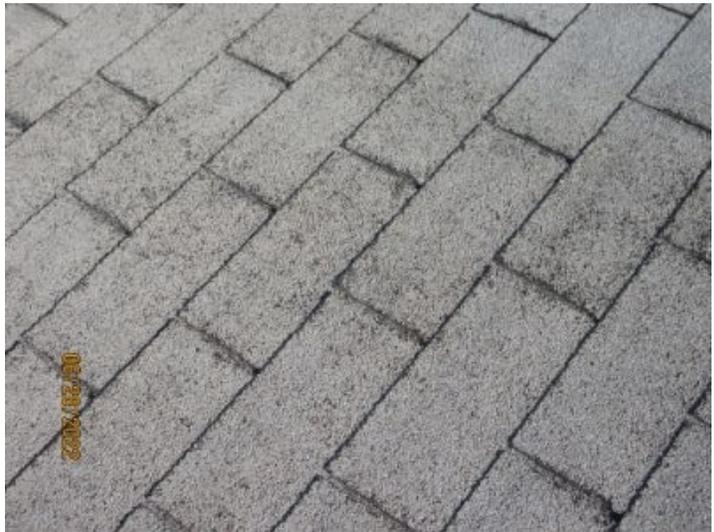
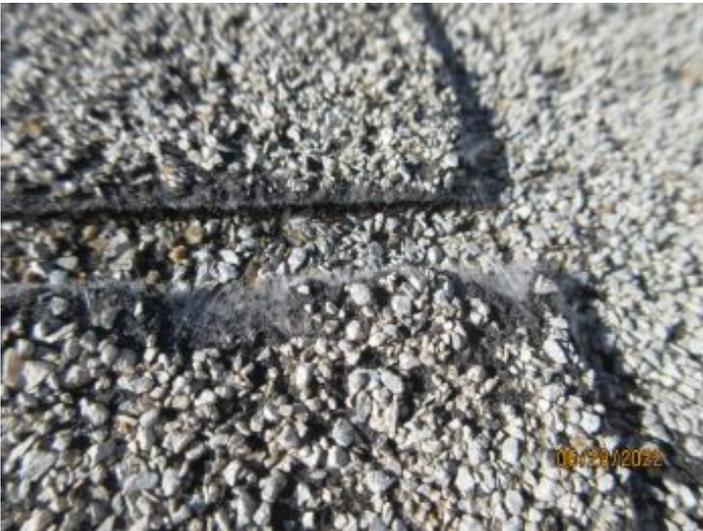
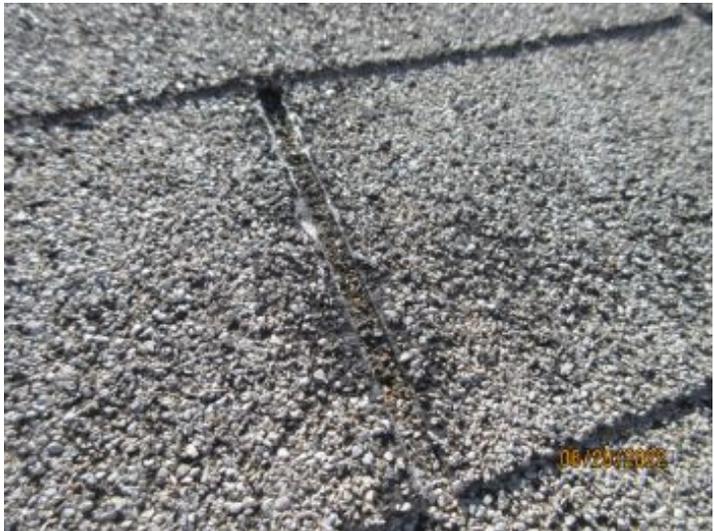
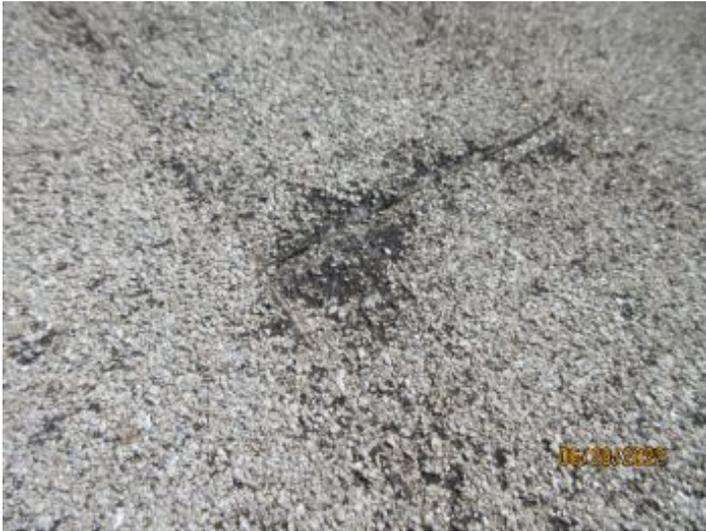
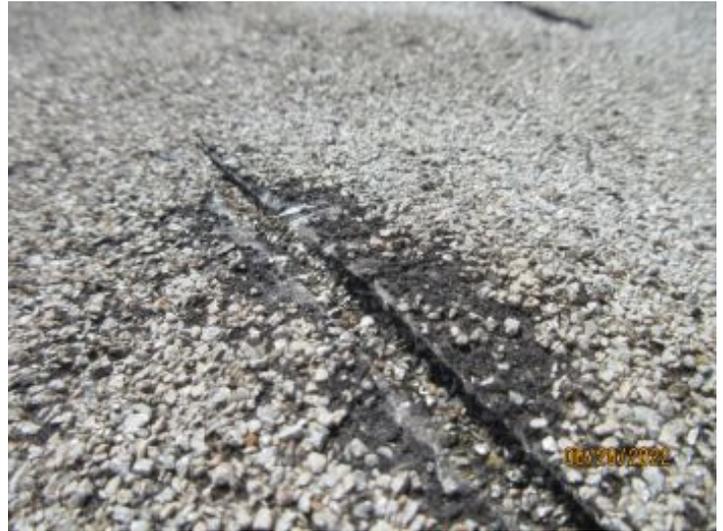
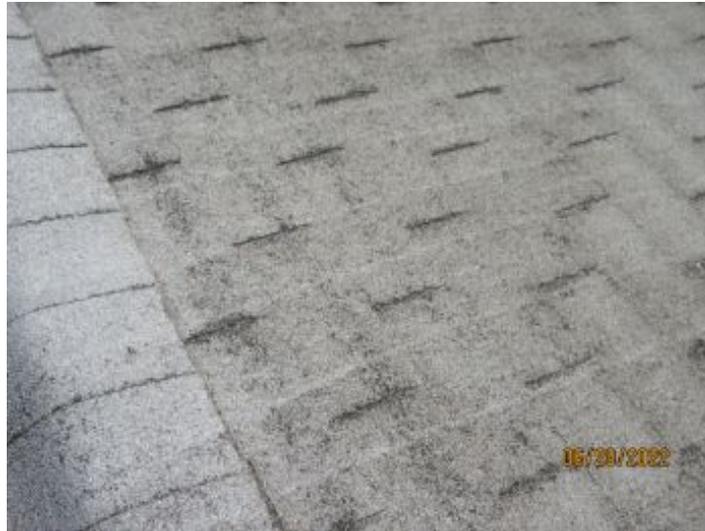
**Granule loss/worn shingles noted. Recommend further review/repair by a qualified roofing contractor.**

Granule loss/worn shingles noted. Recommend further review/repair by a qualified roofing contractor.

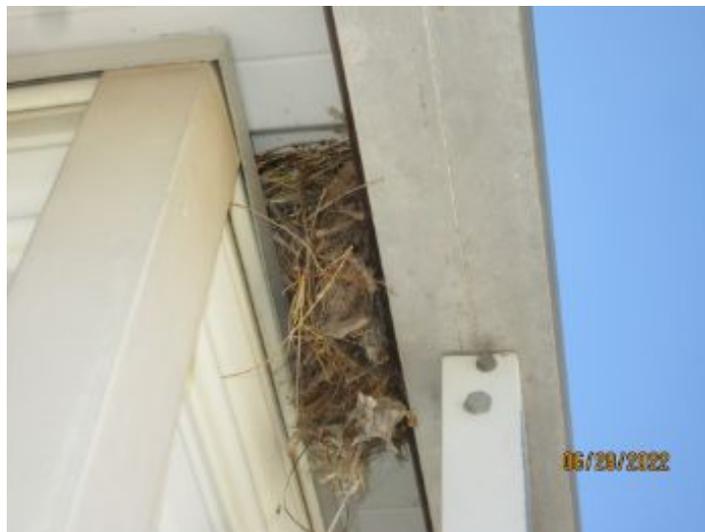
Bird's nest noted under northwest corner roof overhang

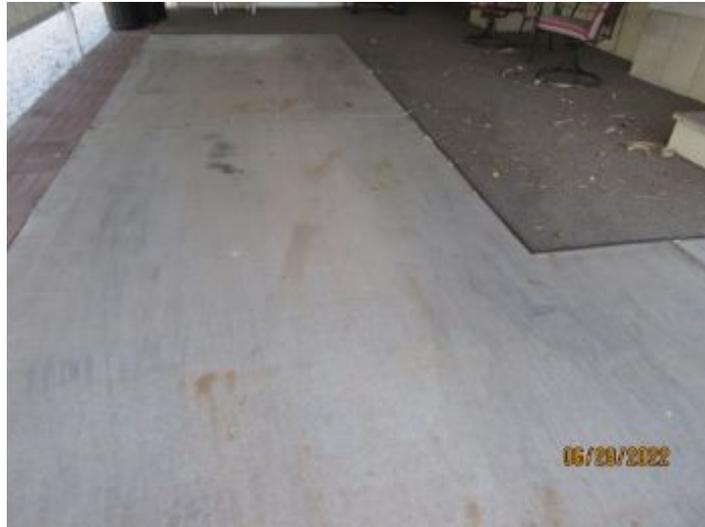
Carport floor was in good condition with common cracking noted

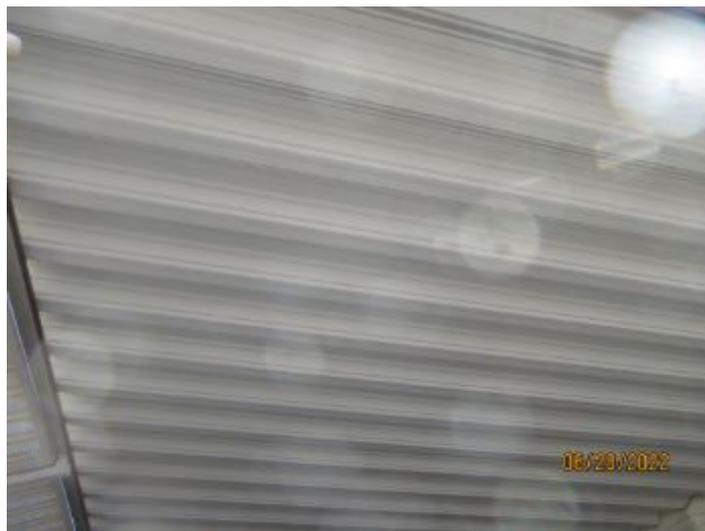
Aluminum panel cover over carport was in good condition at time of inspection.

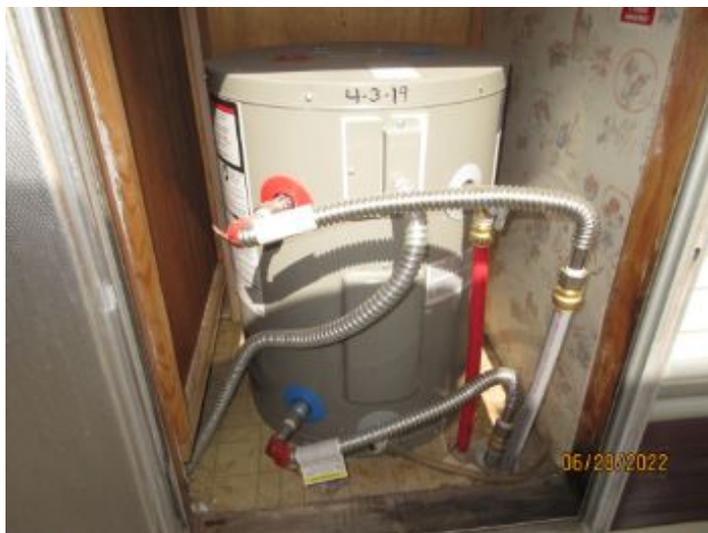
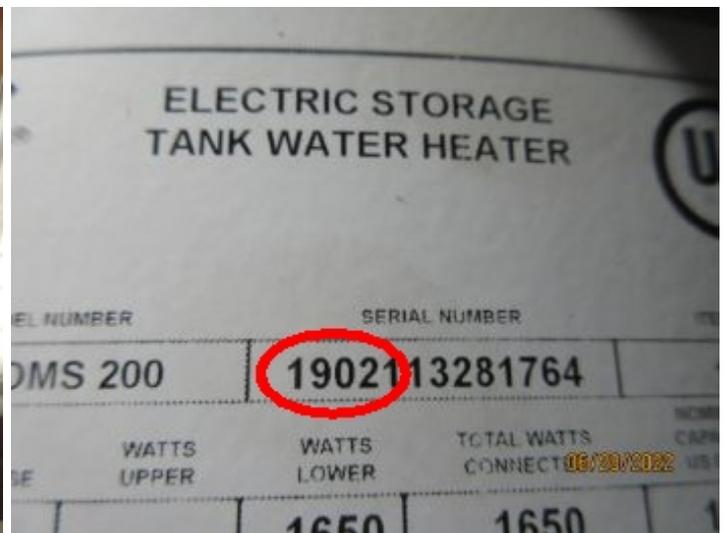
The typical lifespan of a water heater is 7-13 years. Some will last for a shorter time frame and some will last for a longer time frame. Check for rust/corrosion at the water heater plumbing fittings. If leaks occur at the water heater or the hot water recovery time increases contact a qualified plumbing contractor for further review. This unit was providing hot water at the time of inspection. This unit was manufactured in February of 2019.

Water heater was manufactured in February of 2019.

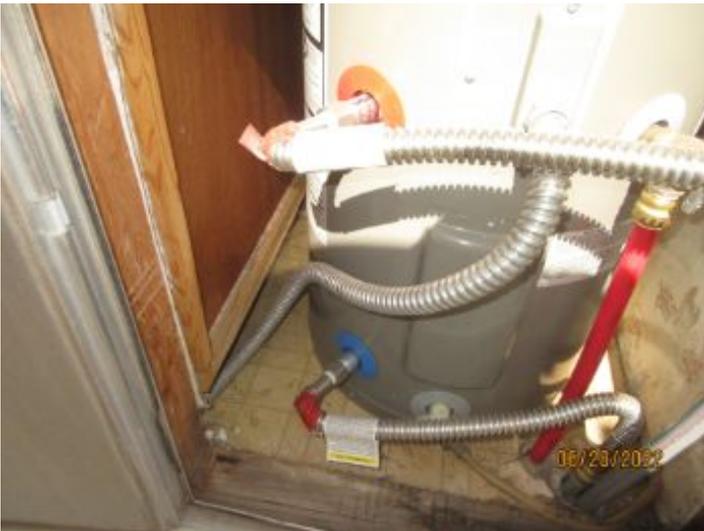
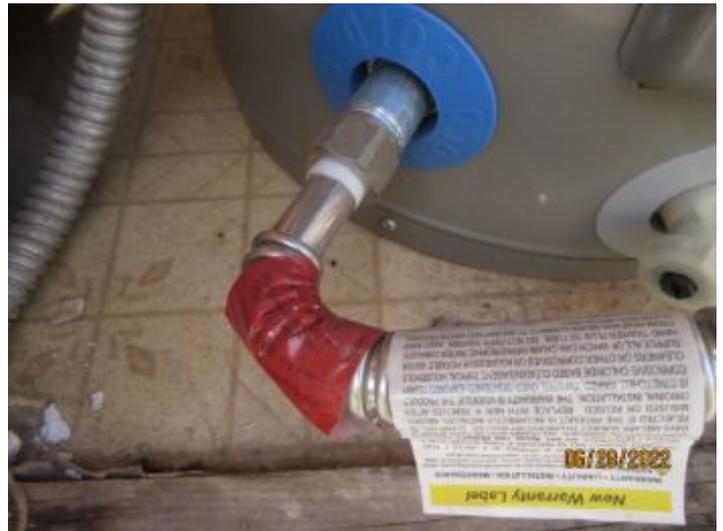
Plumbing connections were in good condition at time of inspection. No evidence of rust or corrosion.

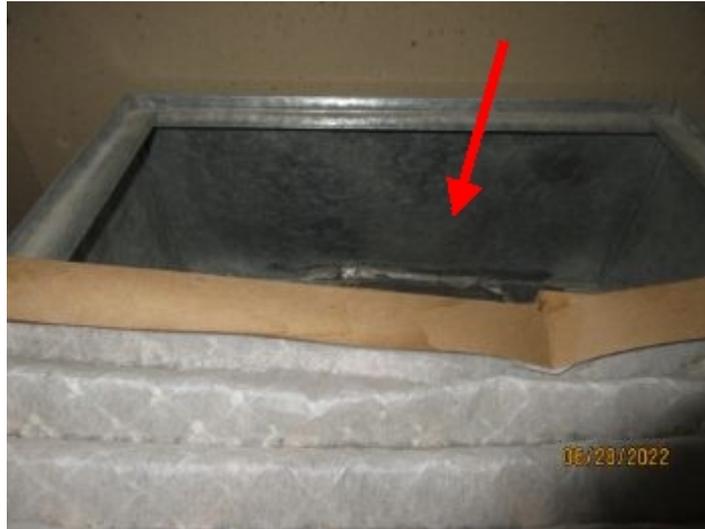
**Furnace filter was installed sideways at the time of inspection.  
Recommend further review/cleaning by a qualified HVAC contractor.**

Furnace filter was installed sideways at the time of inspection. Recommend further review/cleaning by a qualified HVAC contractor.

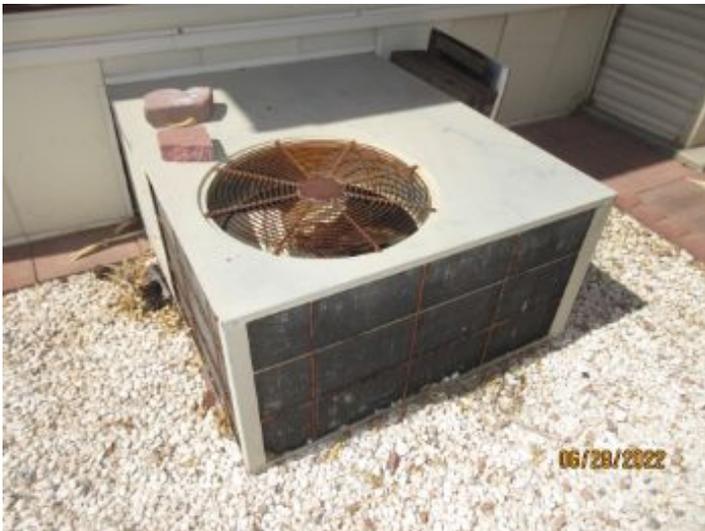
An average split temperature differential between the supply and return ducts is typically 16 to 22 degrees. Temperatures within this range indicate the A/C was cooling as intended at the time of inspection. The average temperature difference noted at the time of inspection was 20 degrees which indicates that the system's temperature split was within the normal range.

The A/C unit provided cold air at time of inspection with temperature differentials within the 16 - 22 degree industry average.

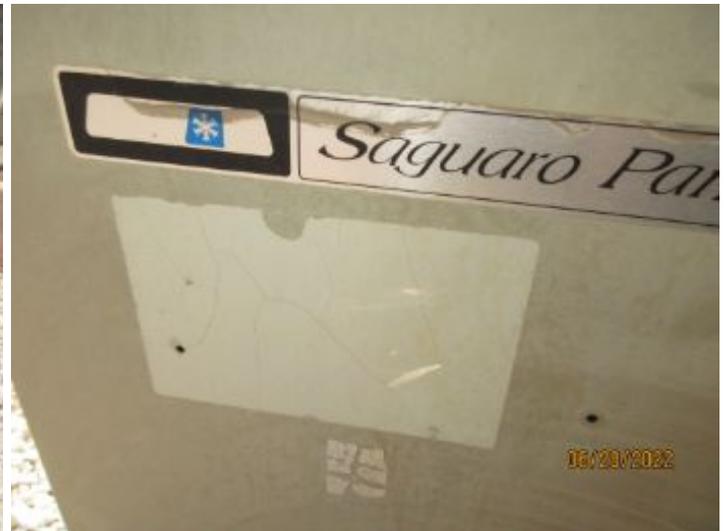
Size and age not determined due to manufacturers plate was faded at the time of inspection.

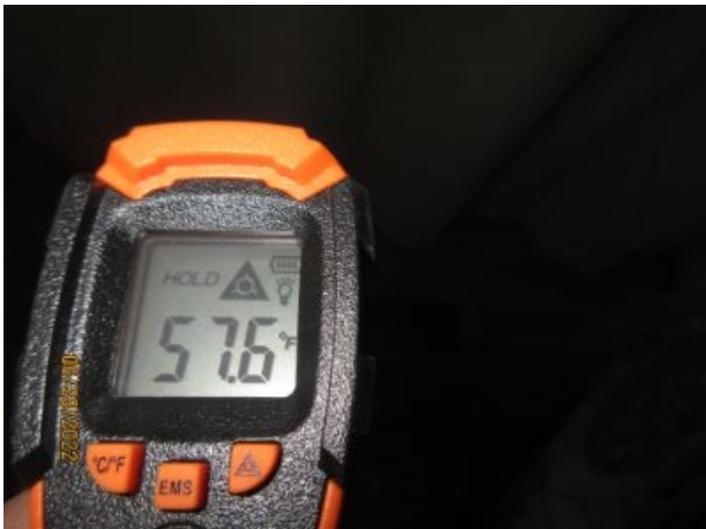
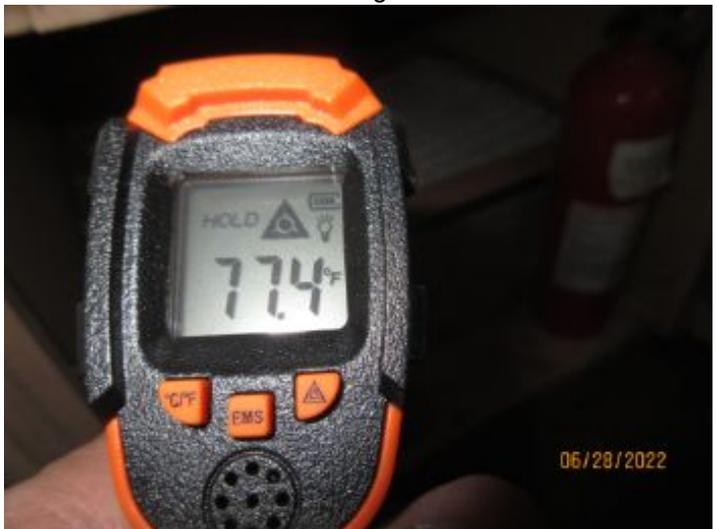
The A/C unit provided cold air at time of inspection with temperature differentials within the 16 - 22 degree industry average.

An average split temperature differential between the supply and return ducts is typically 16 to 22 degrees. Temperatures within this range indicate the A/C was cooling as intended at the time of inspection. The average temperature difference noted at the time of inspection was 20 degrees which indicates that the system's temperature split was within the normal range.

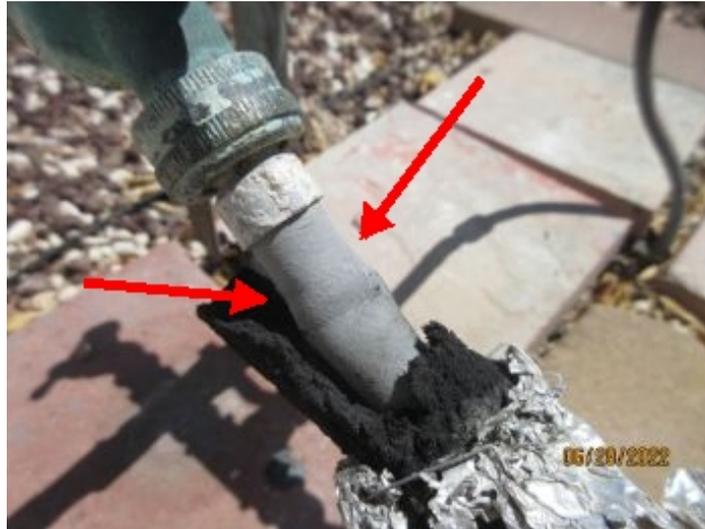
**The plastic pipe next to the water shutoff location in the northeast corner of the home appears to be deteriorated from sun exposure. Recommend further review/repair by a qualified plumbing contractor.**

The plastic pipe next to the water shutoff location in the northeast corner of the home appears to be deteriorated from sun exposure. Recommend further review/repair by a qualified plumbing contractor.

Page 30 Item: 1	Main Water Line	<b>The plastic pipe next to the water shutoff location in the northeast corner of the home appears to be deteriorated from sun exposure. Recommend further review/repair by a qualified plumbing contractor.</b>
Electrical		
Page 33 Item: 3	Electrical Panel Comments	<b>Unprotected opening(s) observed at electric panel, - safety issue, children could reach into panel and get shocked. Recommend further review/repair by a qualified electrician.</b>
Interior Areas		
Page 36 Item: 1	Exterior Door Comments	<b>Exterior door at north end of carport sticks at top jamb. Recommend further review/repair by a qualified contractor.</b>
Page 38 Item: 9	Smoke Detector Comments	<b>No smoke alarms were installed in this home at the time of inspection. I highly recommend installing smoke alarms in all proper locations including the bedroom to enhance the safety of occupants and guests.</b>

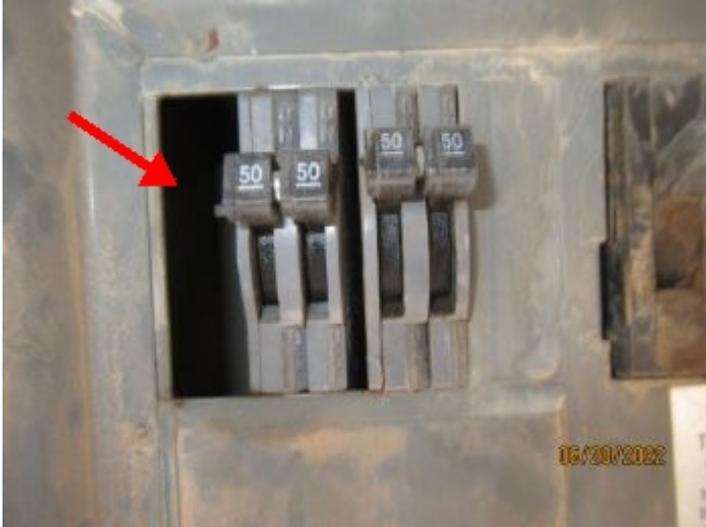
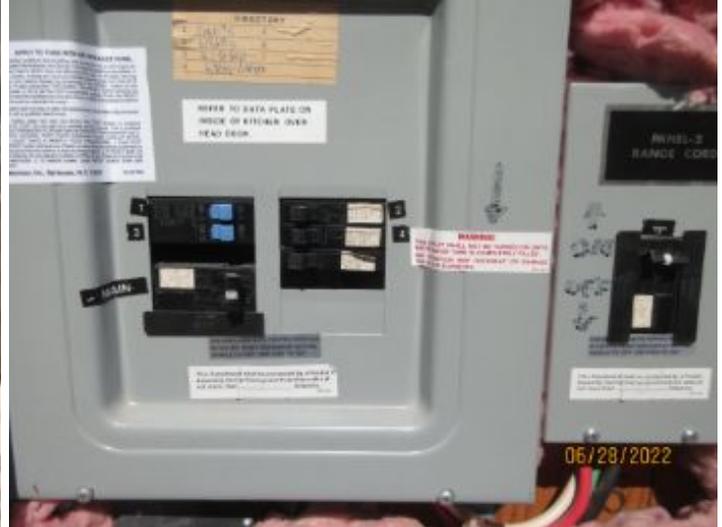
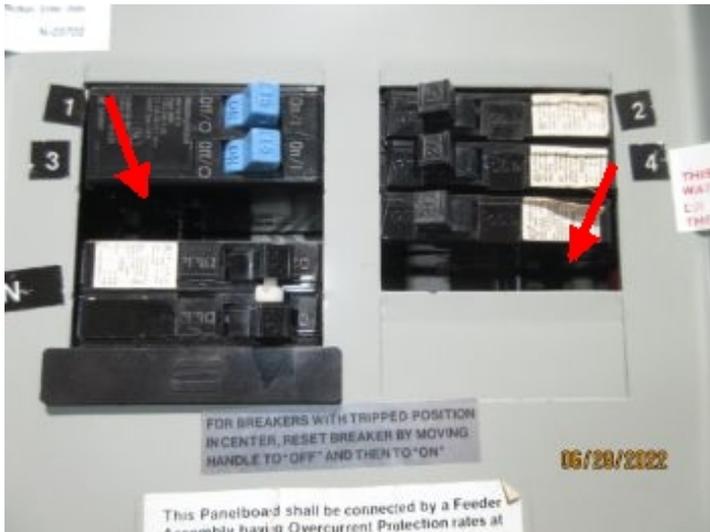
**Unprotected opening(s) observed at electric panel, - safety issue, children could reach into panel and get shocked. Recommend further review/repair by a qualified electrician.**

Unprotected opening(s) observed at electric panel, - safety issue, children could reach into panel and get shocked. Recommend further review/repair by a qualified electrician.

Not all breakers are marked/identified. Recommend having an electrician identify and mark each breaker for all units.

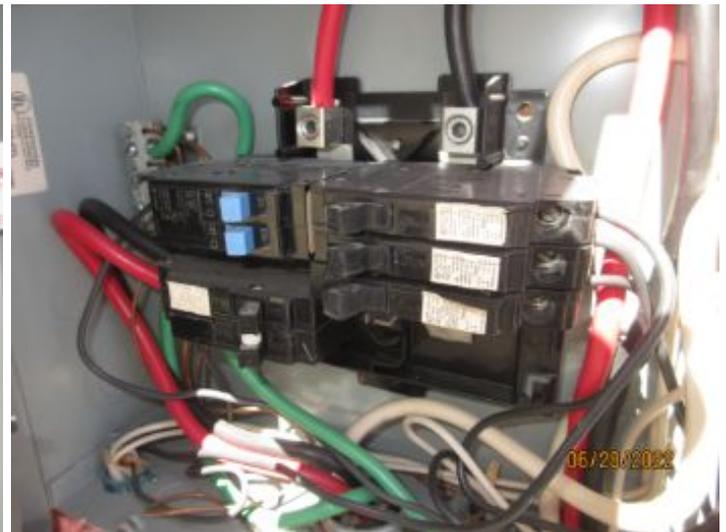
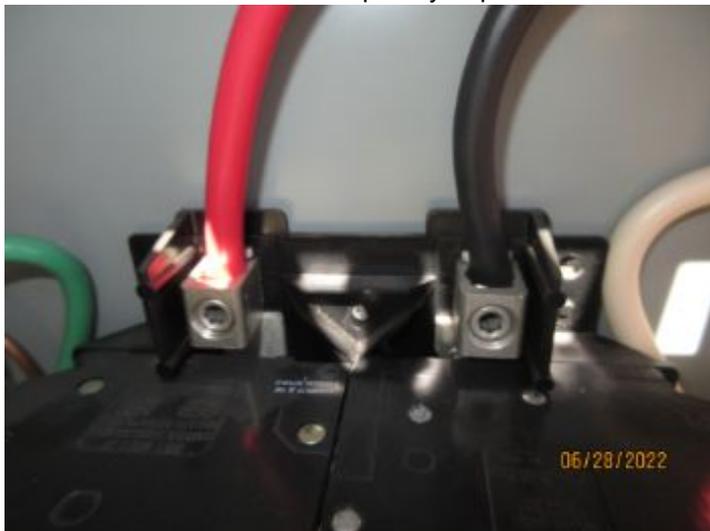
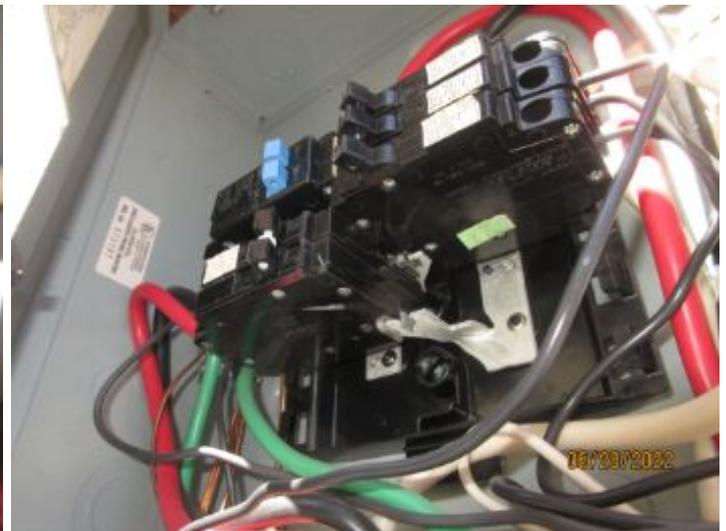
The branch wires visible in the panel are copper and are in satisfactory condition.

Power Supply Cable Type: Copper

Electric panel wiring appears to be well organized.

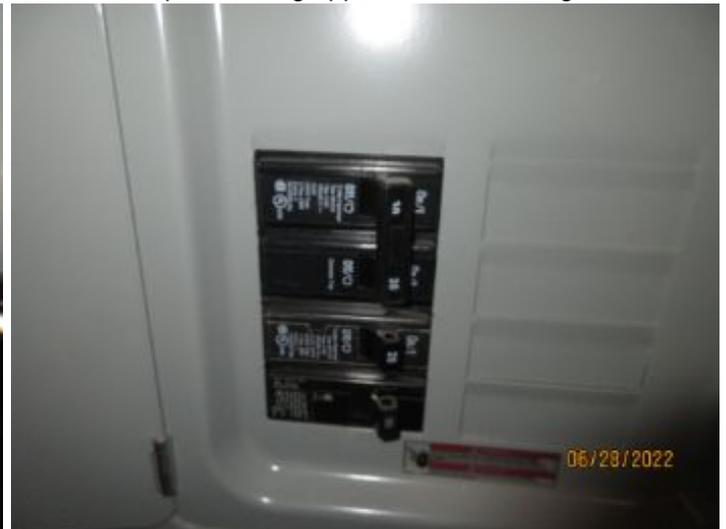
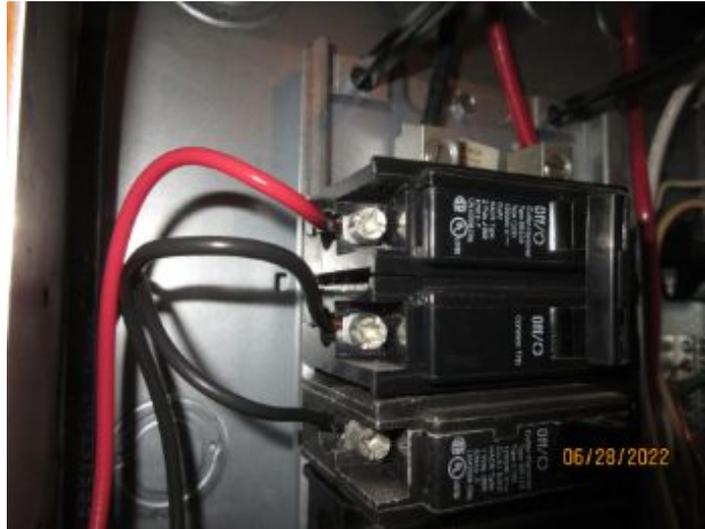
The ground wires were visible in the main electric panel and appeared to be properly secured at the time of inspection.

Not all breakers are marked/identified. Recommend having an electrician identify and mark each breaker for all units.

Electric panel wiring appears to be well organized.

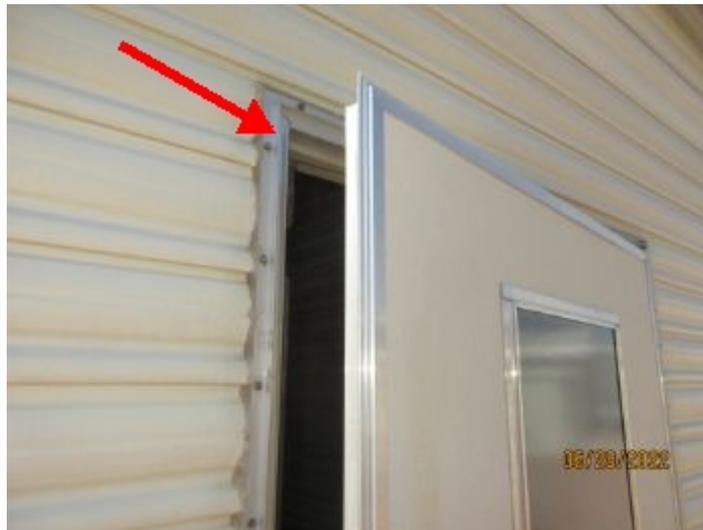
**Exterior door at north end of carport sticks at top jamb. Recommend further review/repair by a qualified contractor.**

Exterior door at north end of carport sticks at top jamb. Recommend further review/repair by a qualified contractor.

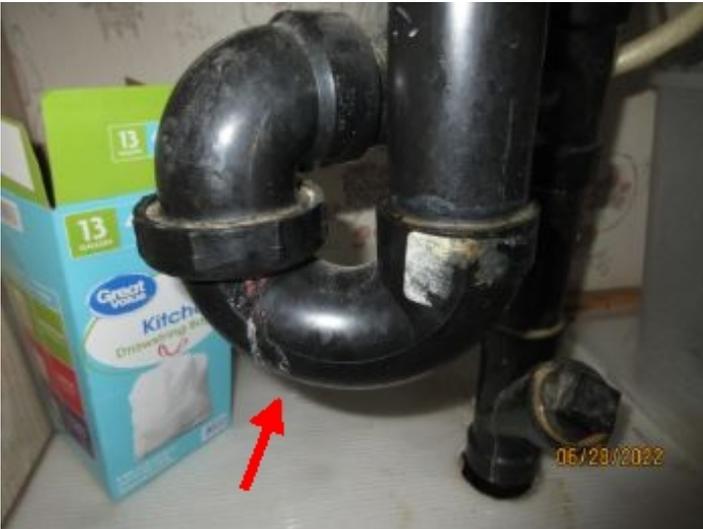
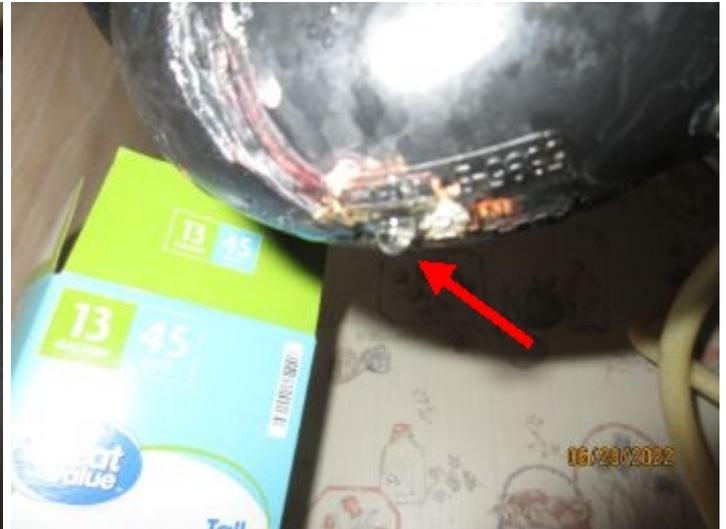
**Active drip noted at kitchen sink drain plumbing connection. Recommend further review/repair by a qualified plumbing contractor.**

Active drip noted at kitchen sink drain plumbing connection. Recommend further review/repair by a qualified plumbing contractor.

Page 40 Item: 5	Kitchen Plumbing Comments	<b>Active drip noted at kitchen sink drain plumbing connection. Recommend further review/repair by a qualified plumbing contractor.</b>
Page 42 Item: 11	Kitchen GFCI Comments	<b>As of 1987 all kitchen receptacles within 6 feet of a water source are required to be GFCI protected as a safety feature. That may not have been the case when this home was built. Recommend having a qualified electrician install GFCI at all applicable locations to bring home up to current building standards for enhanced safety to occupants</b>

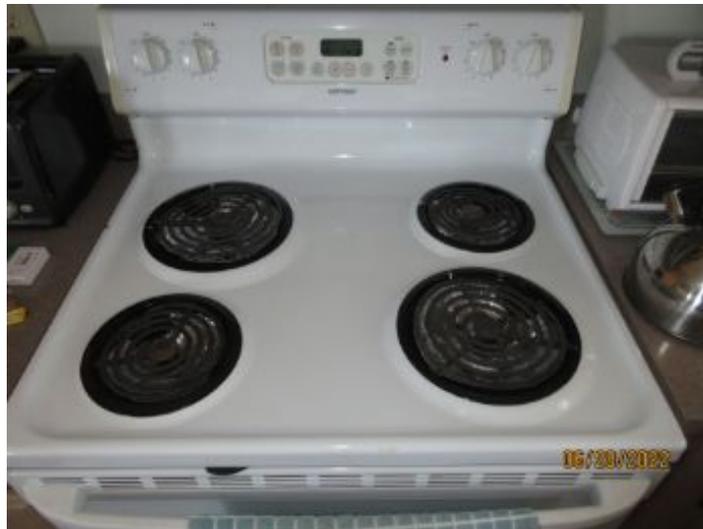
**All 4 burners heated up when switched to the on position at time of inspection.**

All 4 burners heated up when switched to the on position at time of inspection.

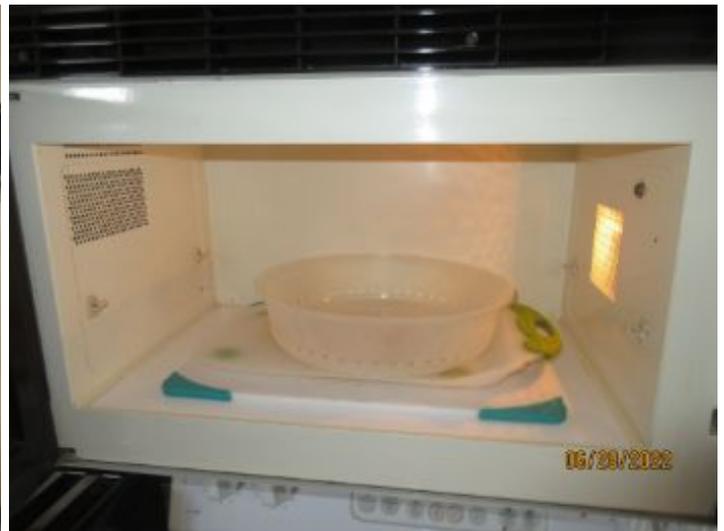
Microwave heated water at time of inspection

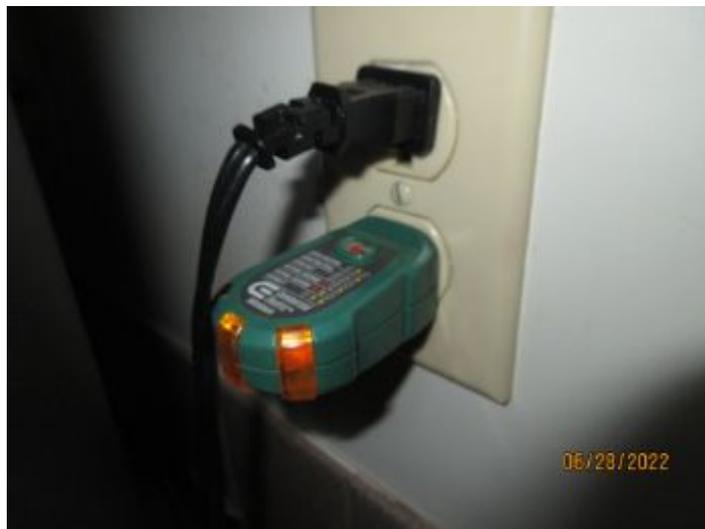
**As of 1987 all kitchen receptacles within 6 feet of a water source are required to be GFCI protected as a safety feature. That may not have been the case when this home was built. Recommend having a qualified electrician install GFCI at all applicable locations to bring home up to current building standards for enhanced safety to occupants**

As of 1987 all kitchen receptacles within 6 feet of a water source are required to be GFCI protected as a safety feature. That may not have been the case when this home was built. Recommend having a qualified electrician install GFCI at all applicable locations to bring home up to current building standards for enhanced safety to occupants

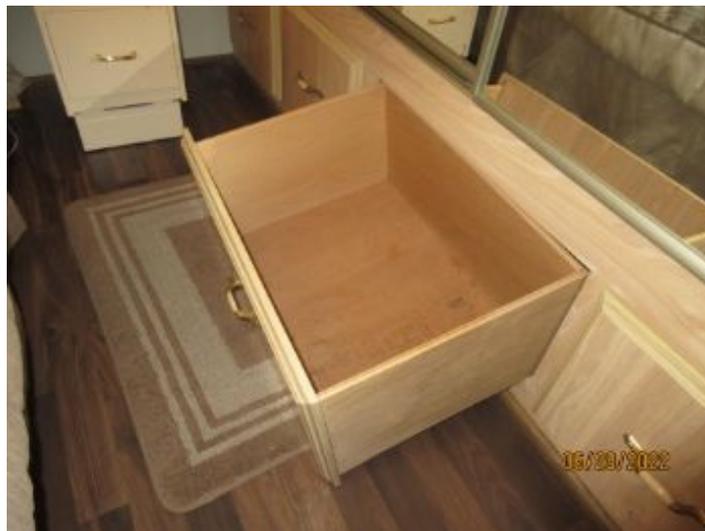
One or more drawers below closet need minor repairs.

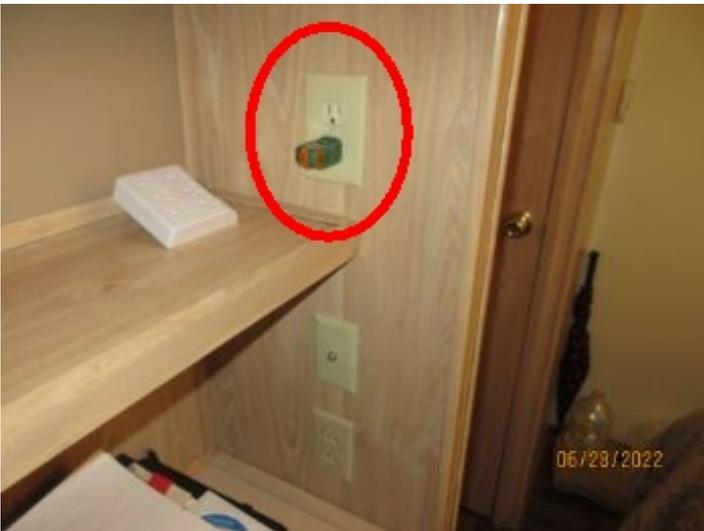
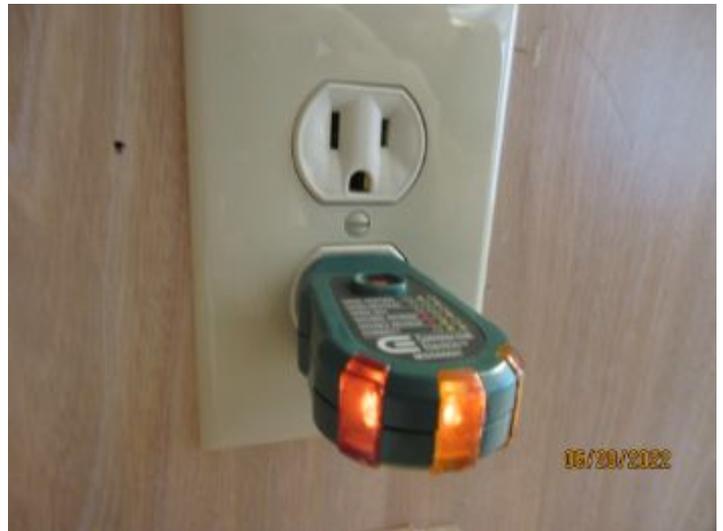
**Upper outlet on south wall of bedroom appears to have the hot and neutral wires reversed. Recommend further review/repair by a qualified electrician.**

Upper outlet on south wall of bedroom appears to have the hot and neutral wires reversed. Recommend further review/repair by a qualified electrician.

Page 45 Item: 8	Bedroom Electrical Comments	<b>Upper outlet on south wall of bedroom appears to have the hot and neutral wires reversed. Recommend further review/repair by a qualified electrician.</b>
Page 45 Item: 10	Bedroom Smoke Detector Comments	<b>No smoke detector installed in guest bedroom</b>

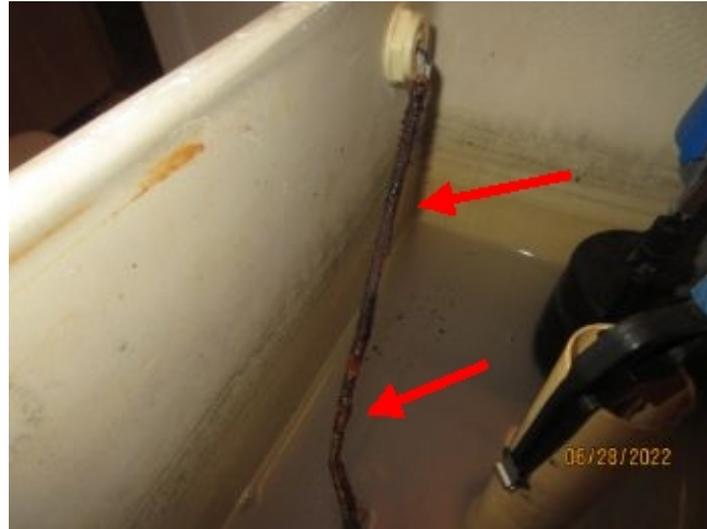
Rust noted at toilet handle flush arm.
