# The Inspector

Park Model Lane, Apache Junction, 85120  
Inspection prepared for: John and Mary Another sample  
Date of Inspection: 6/28/2022 Time: 8:30am - 3:15pm  
Age of Home: Built in 1989 Size: 399 S.F.  
Weather: Sunny, 100's. Rain in past 72 hours.  
Front of House Faces: South  
Client/Agent Present at Inspection? No  
House Occupied? Yes

## Inspection Summary

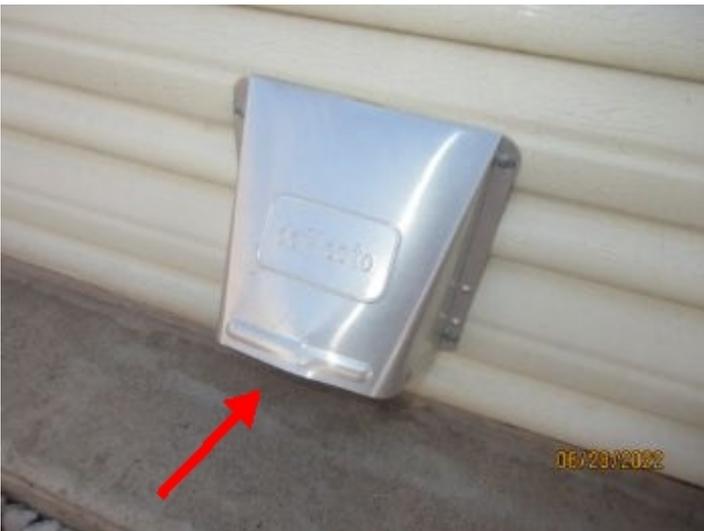
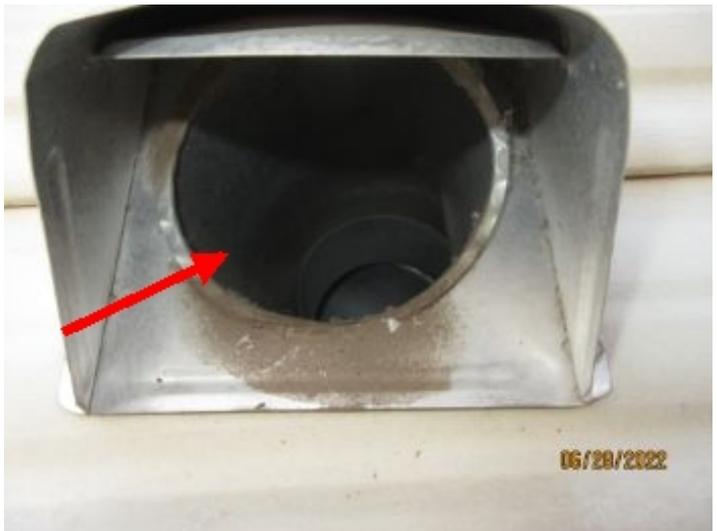
**Dryer vent flapper stuck in the open position on west side of house. Recommend cleaning vent area so that the flapper can close preventing air/insects from entering house.**

Dryer vent flapper stuck in the open position on west side of house. Recommend cleaning vent area so that the flapper can close preventing air/insects from entering house.

Page 50 Item: 2	Dryer Vent Comments	<b>Dryer vent flapper stuck in the open position on west side of house. Recommend cleaning vent area so that the flapper can close preventing air/insects from entering house.</b>
-----------------	---------------------	--

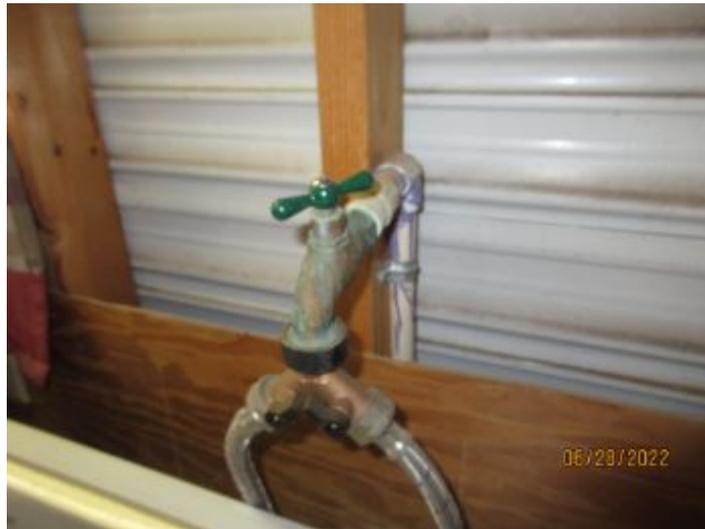
Did not test washer stand pipe as this is beyond the scope of a home inspection

The supply shutoff valve for the washing machine appear to be in good condition with little or no corrosion/rust present at time of inspection
