The Inspector

1234 Main Street, Mesa, AZ 85212
Inspection prepared for: John and Mary Sample
Date of Inspection: 8/9/2022 Time: 6:00am - 5:30pm
Age of Home: Built in 1988 Size: 3338 S.F.
Weather: Partly cloudy, 100's. Showers in past 24 hours.
Front of House Faces: South
Client/Agent Present at Inspection? Both
House Occupied? No

Inspection Summary

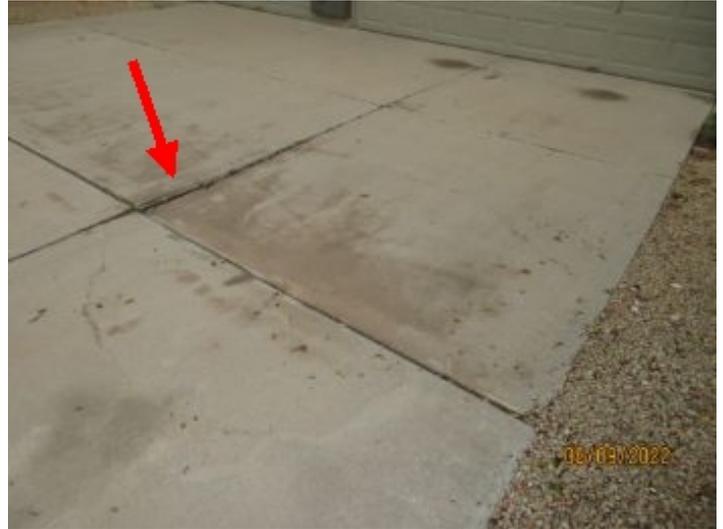
Raised or settled driveway surface noted as being a trip hazard. Repairs recommended to enhance safety to occupants and guests.

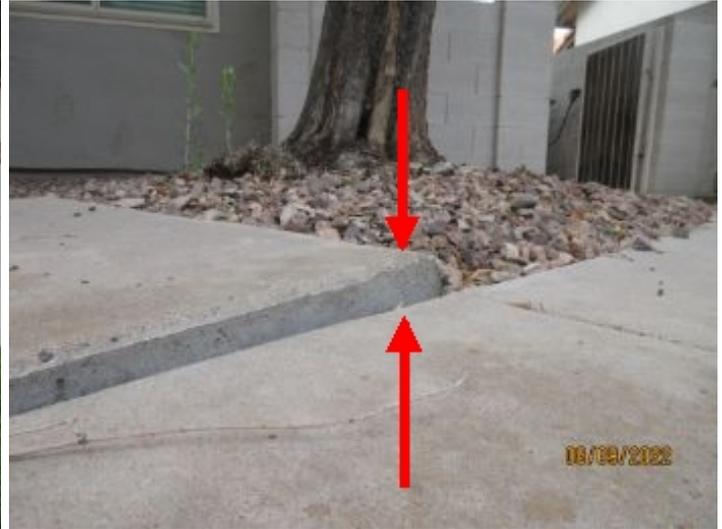
Roots from tree planted on northwest corner of house are lifting sidewalk. Suggest monitoring and repair as needed.

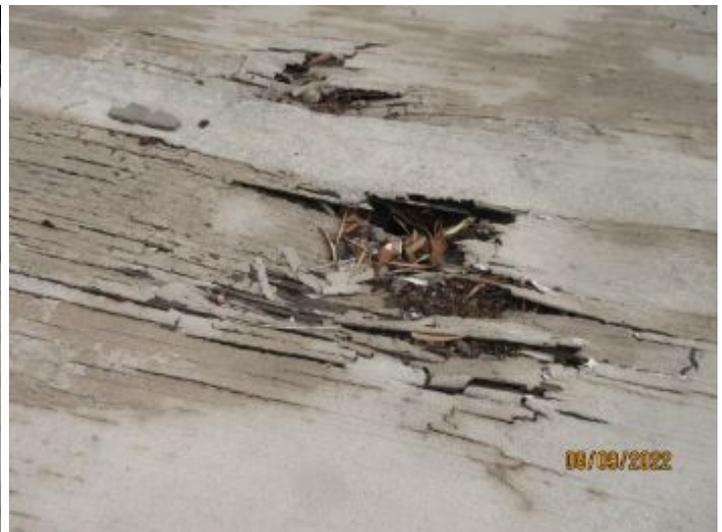
Deck off of master bedroom is rotted/damaged in several locations. Recommend further review/repair by a qualified contractor.

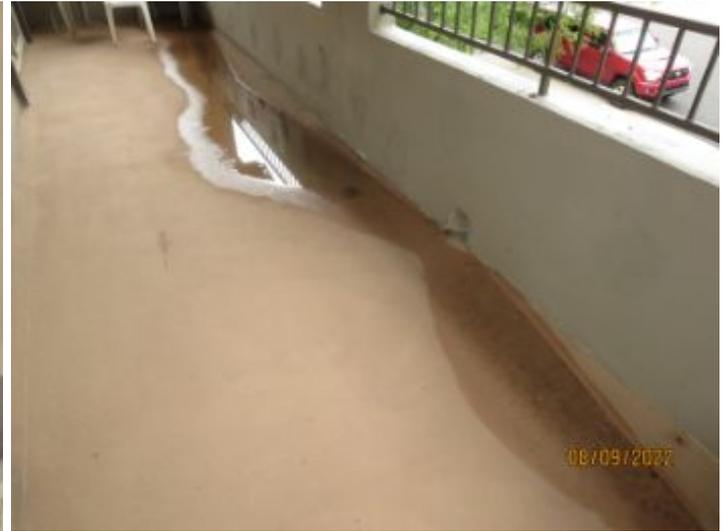
Deck on front of house does not slop towards scuppers to allow proper removal of water. Recommend further review/repair by a qualified contractor.

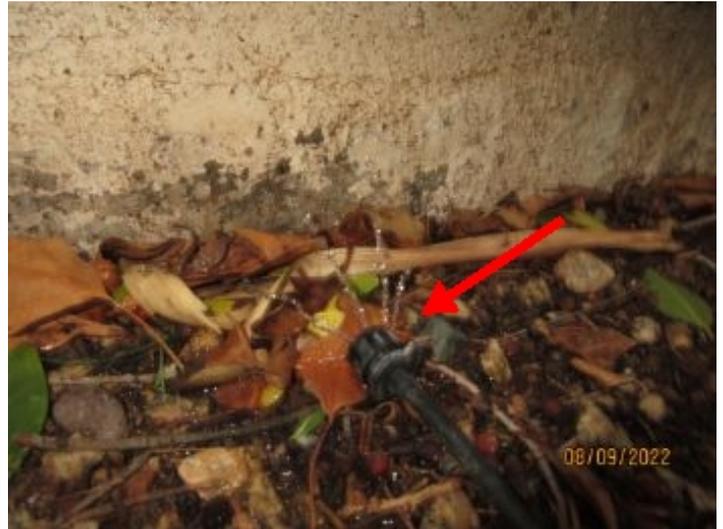
Exposed piping noted in one or more locations. Recommend burying supply lines to extend life of supply lines.

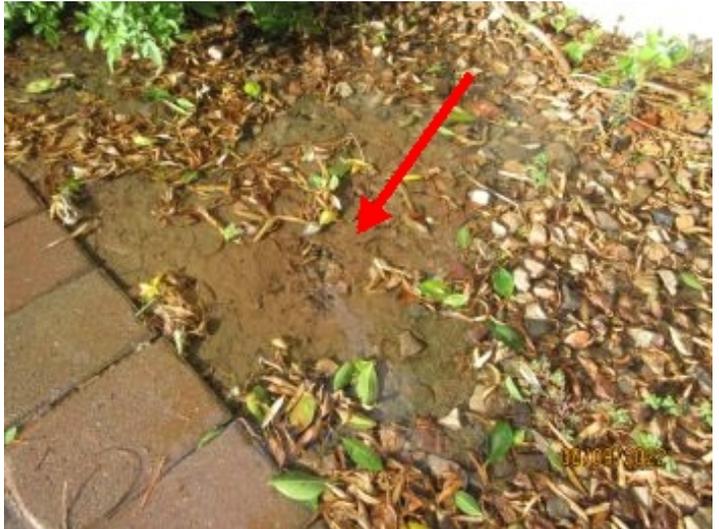
There appears to be a leak in the irrigation supply line at the west side of the back yard near the sub panel. Recommend further review/repair by a qualified landscape contractor.

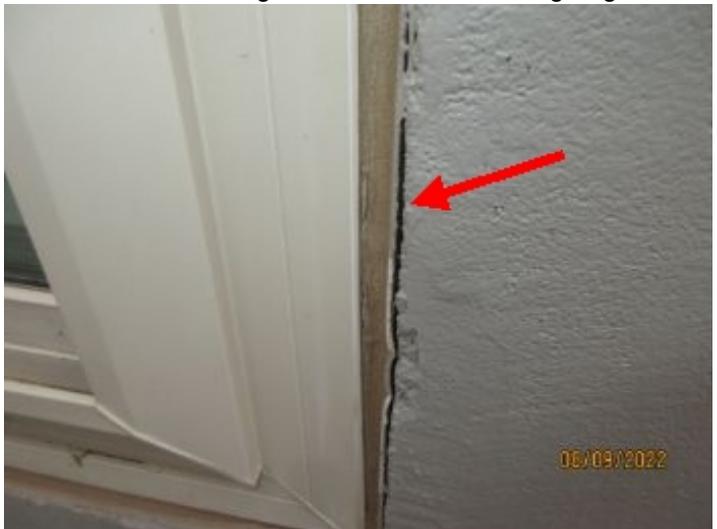
Recommend caulking around windows

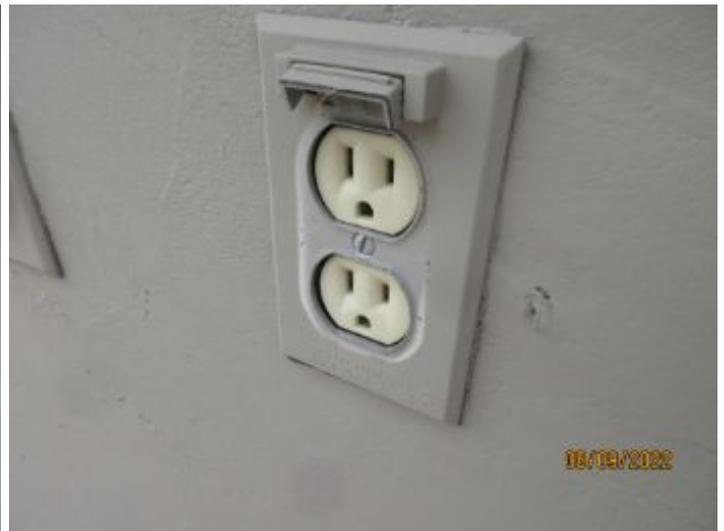
GFCI tested and did not operate correctly at one or more exterior locations. Recommend review and repair by a qualified electrician.

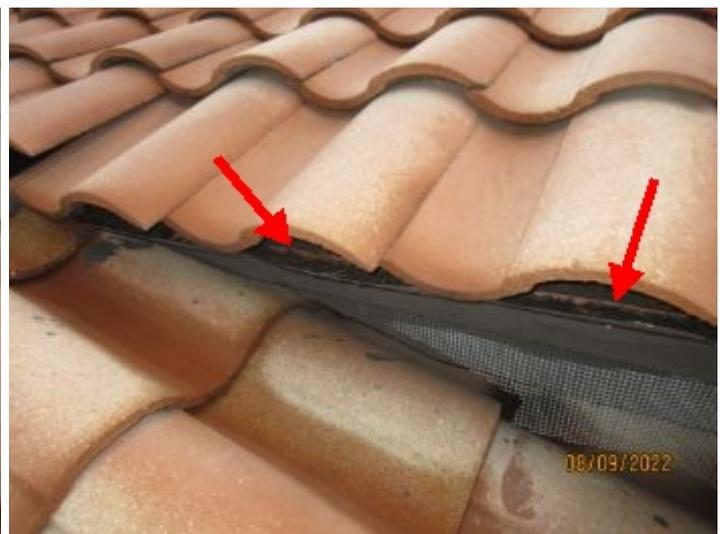
Displaced tile(s)

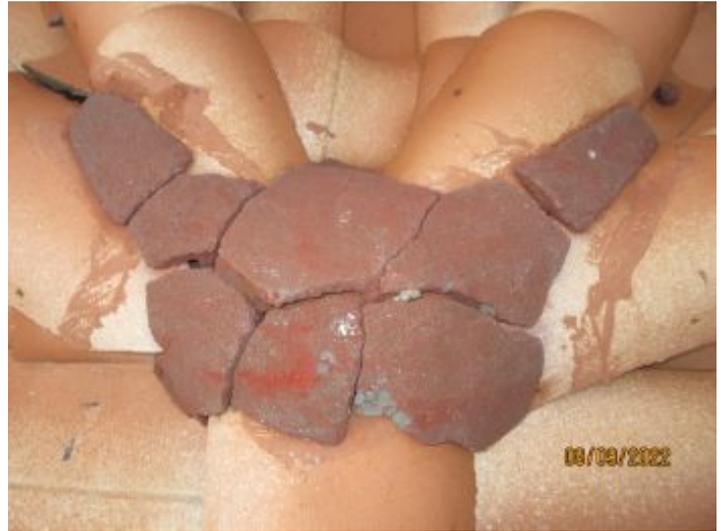
Large amounts of pigeon droppings noted on roof behind wiring. Recommend removing droppings to help facilitate water flow off of roof. Recommend further review/repair by a qualified roofing contractor.

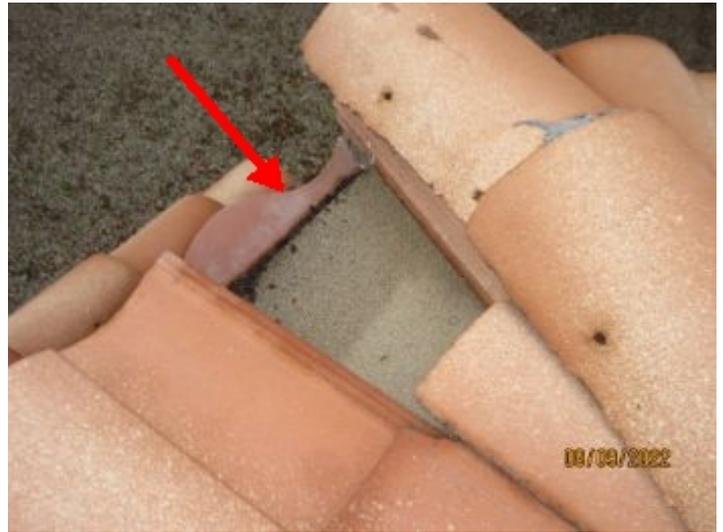
Damaged mortar pack noted in one or more location(s)

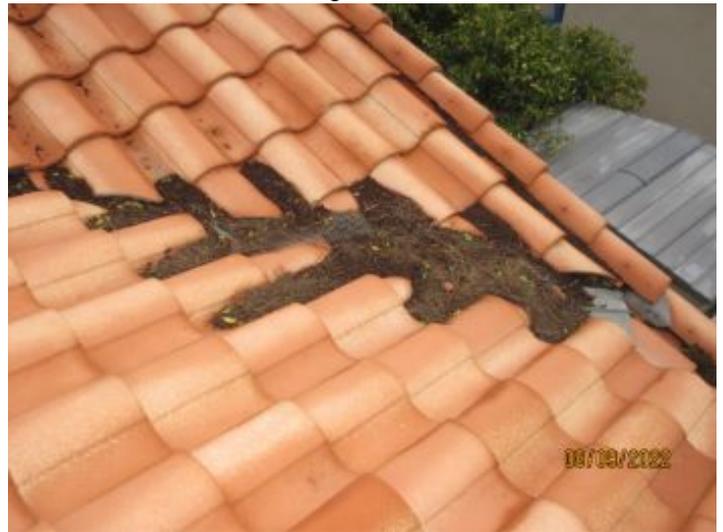
Displaced tile(s)

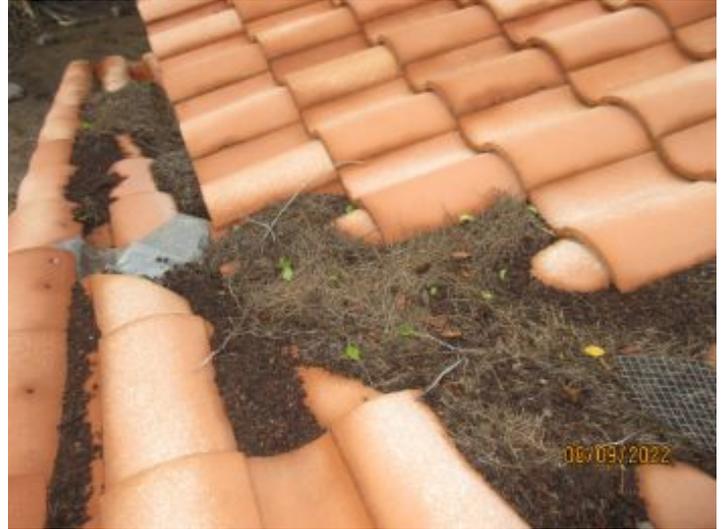
Large amounts of pigeon droppings noted on roof behind wiring. Recommend removing droppings to help facilitate water flow off of roof. Recommend further review/repair by a qualified roofing contractor.

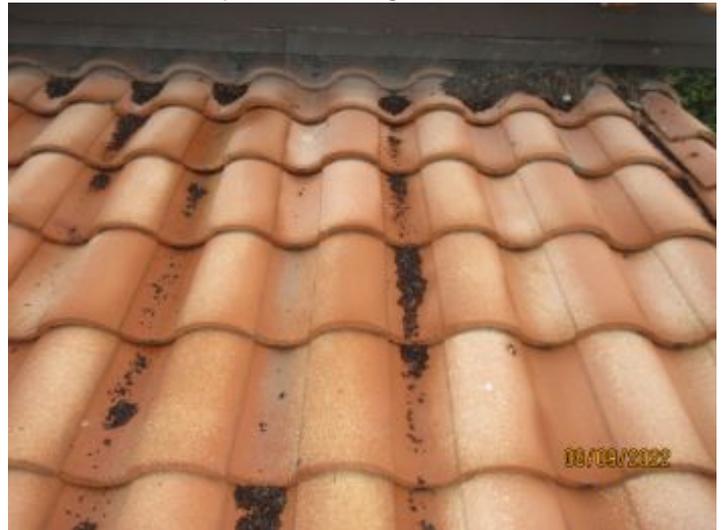
Large amounts of pigeon droppings noted on roof behind wiring. Recommend removing droppings to help facilitate water flow off of roof. Recommend further review/repair by a qualified roofing contractor.

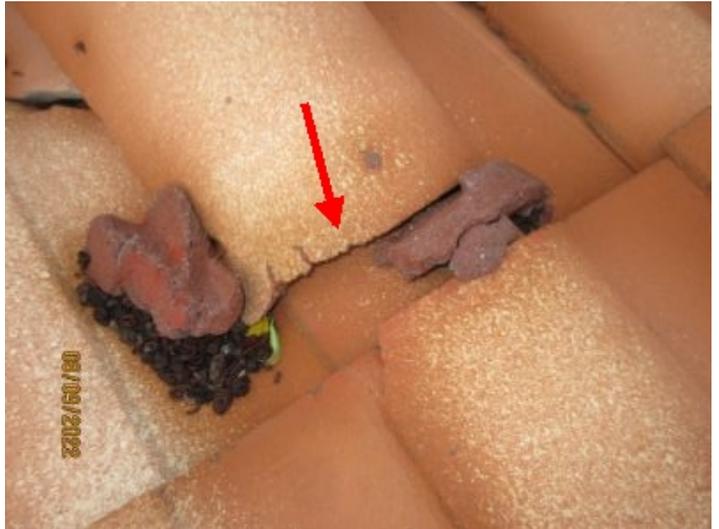
Large amounts of pigeon droppings noted on roof behind wiring. Recommend removing droppings to help facilitate water flow off of roof. Recommend further review/repair by a qualified roofing contractor.

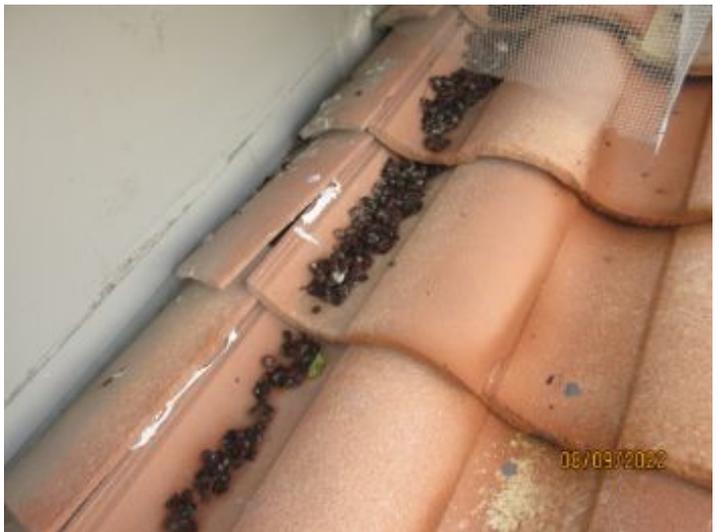
Displaced tile(s)

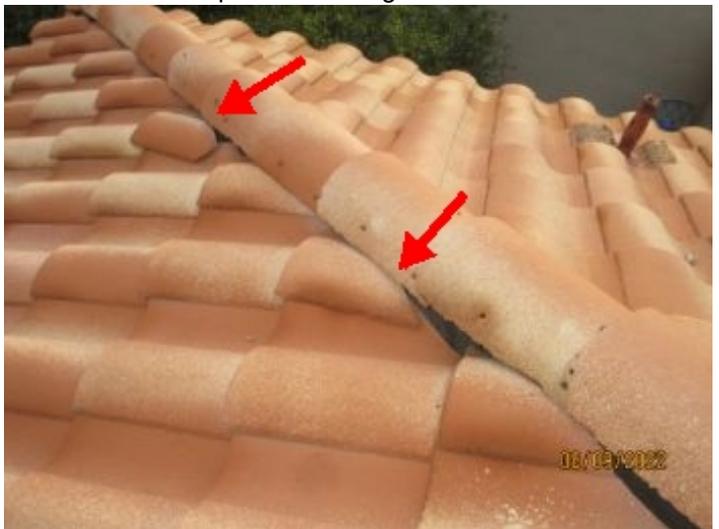
Damaged mortar pack noted in one or more location(s)

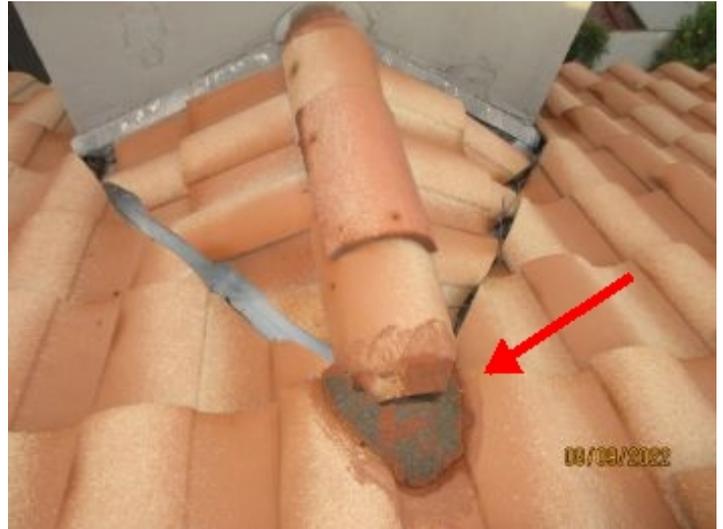
Displaced tile(s)

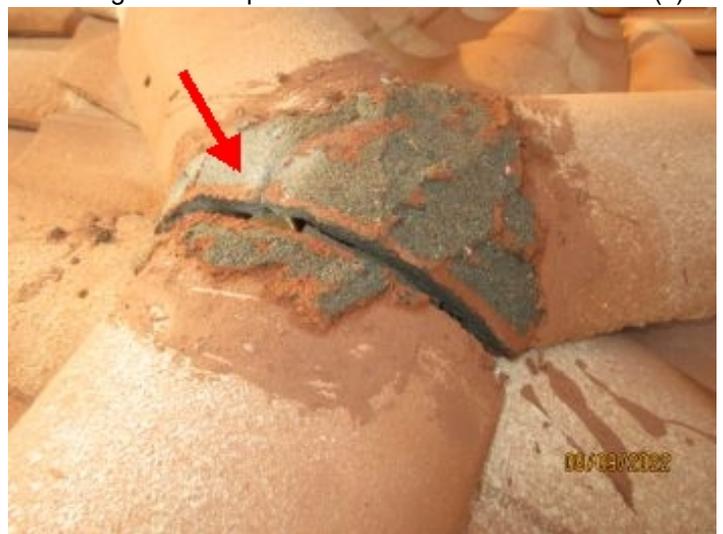
Leaves/pigeon debris noted in one or more area(s) on roof surface. Recommend removal to allow proper drainage off of roof surface.

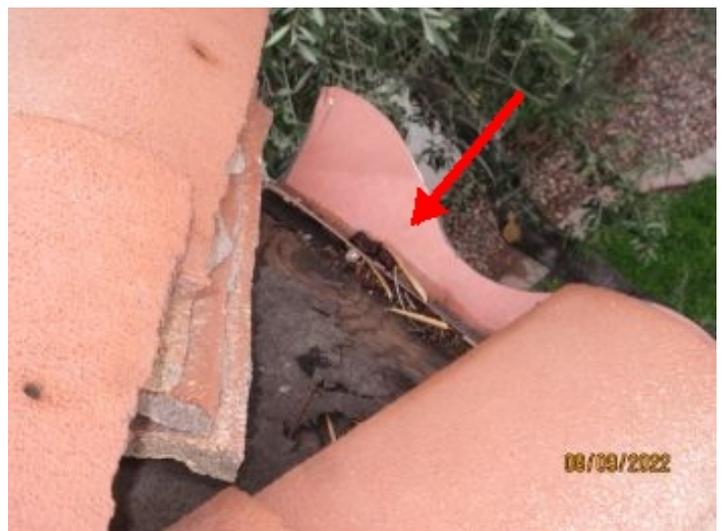
Displaced tile(s)

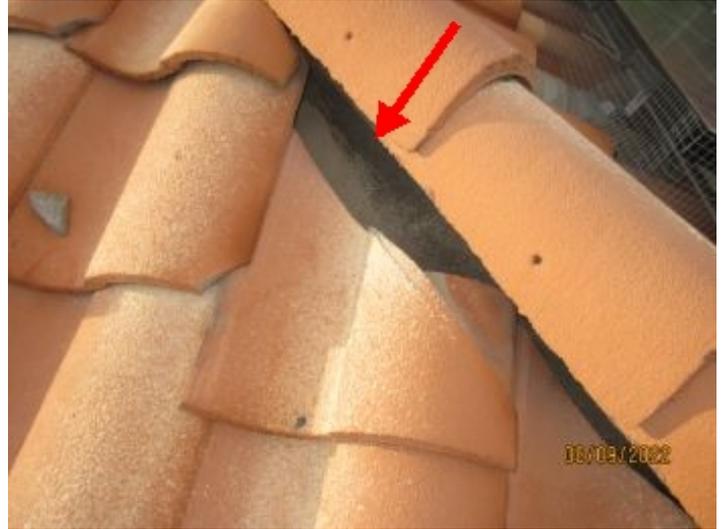
Damaged/deteriorated underlayment noted. Recommend further review/repair by a qualified roofing contractor.

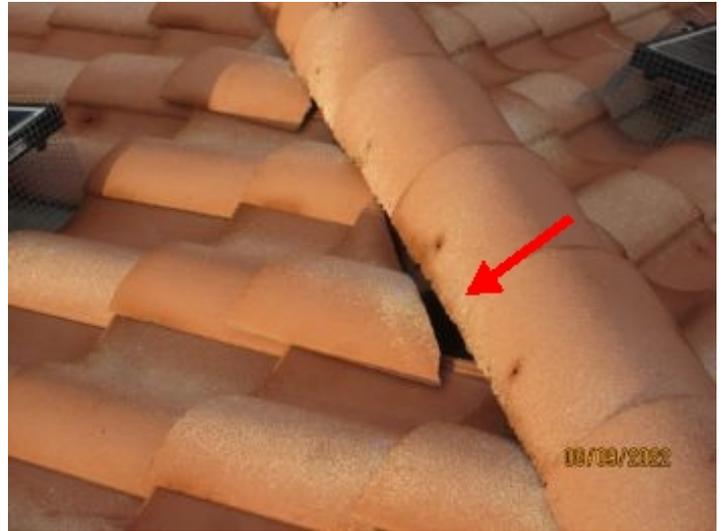
Damaged mortar pack noted in one or more location(s)

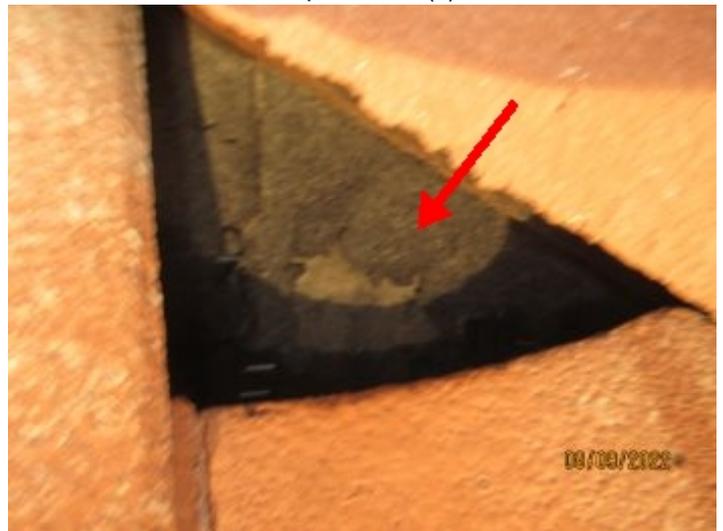
Displaced tile(s)

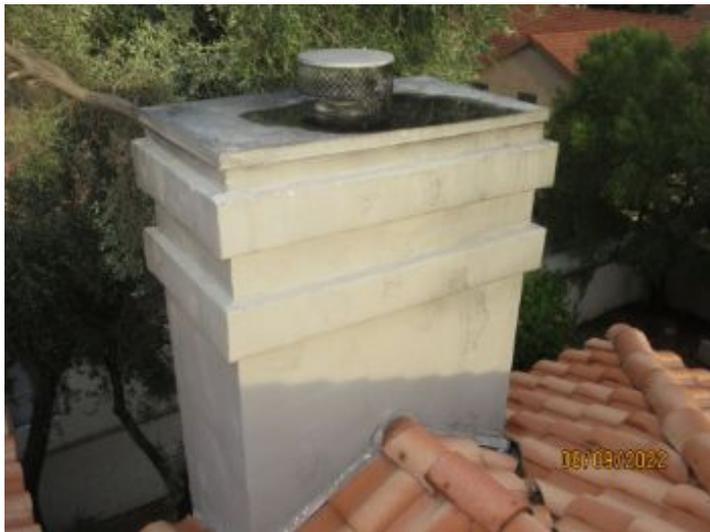
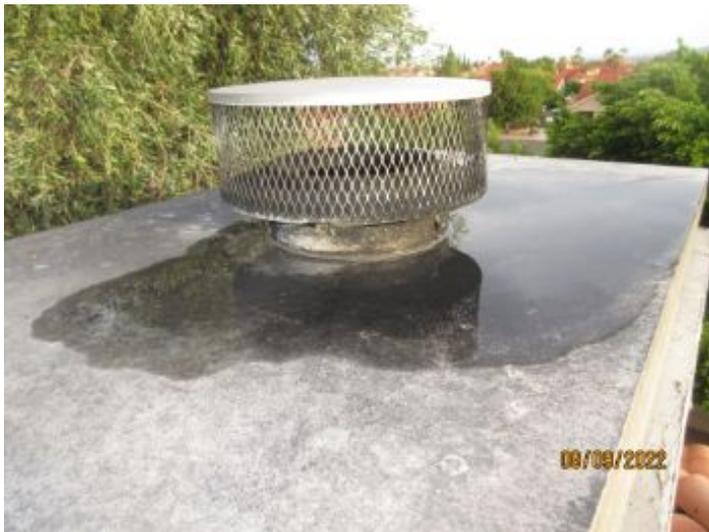
Stucco damage noted at chimney. Recommend repair to help prevent moisture from potentially entering structure.

Water was pooling on top of the chimney at the time of inspection. Recommend further review/repair by a qualified roofing contractor.

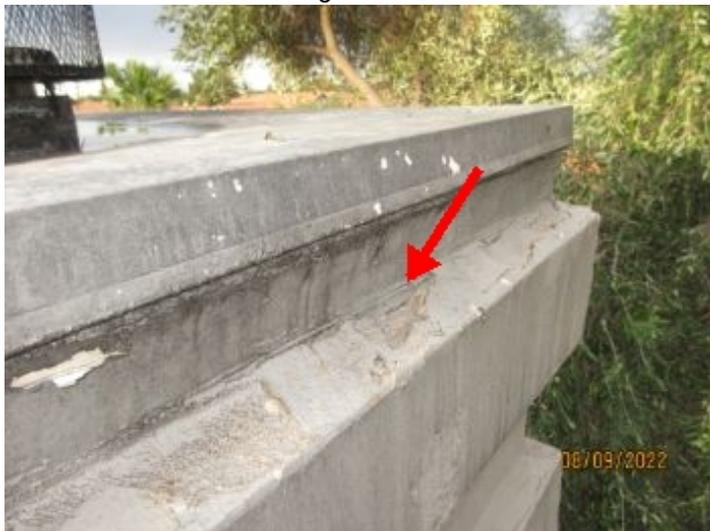
Water was pooling on top of the chimney at the time of inspection. Recommend further review/repair by a qualified roofing contractor.

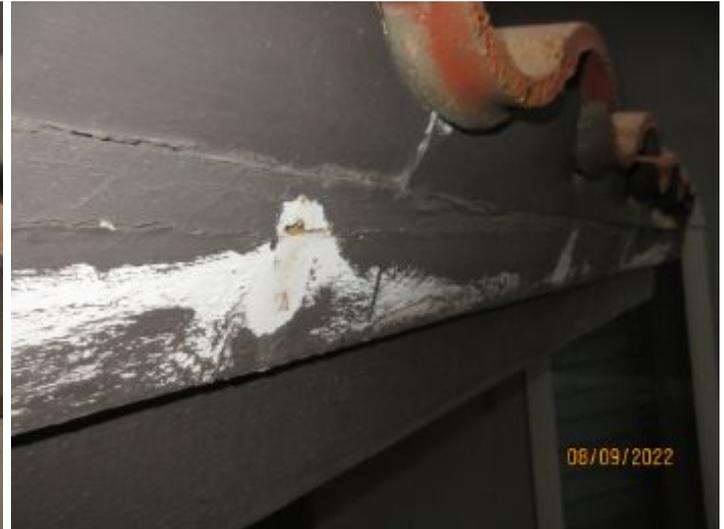
Peeling/Deteriorated paint noted in areas of the soffit and/or fascia, recommend using a quality exterior paint to extend its useful service life.

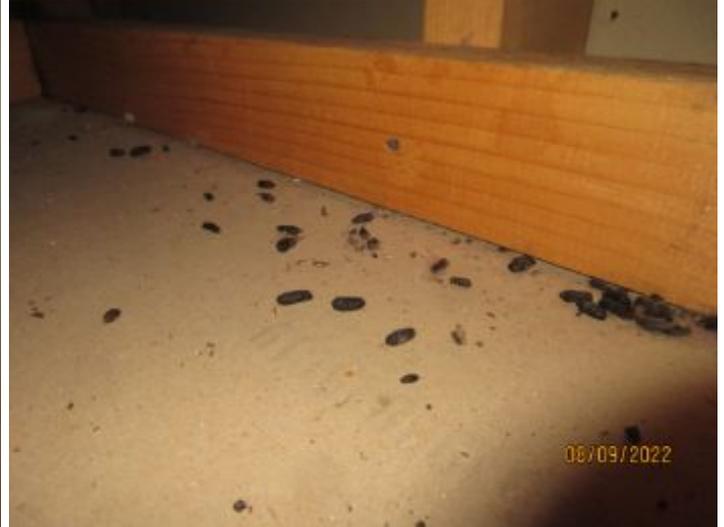
Location 1: Master bedroom closet ceiling

Mouse/rat droppings noted inside attic. No live rodents noted at the time of inspection.

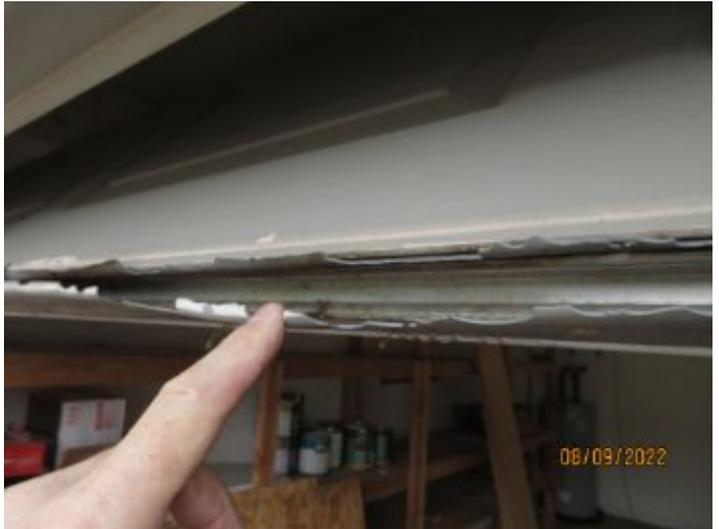
Damaged/deteriorated side and/or top door seals noted. Recommend replacement to help keep moisture, insects out of garage.

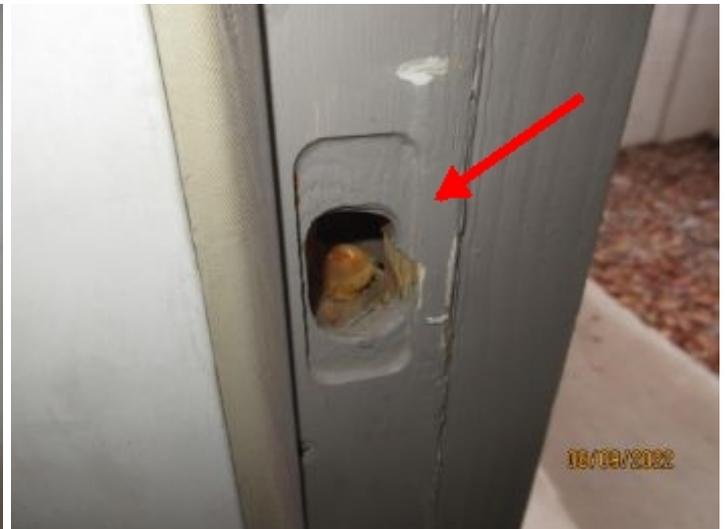
Missing striker plate at deadbolt on exterior garage door.

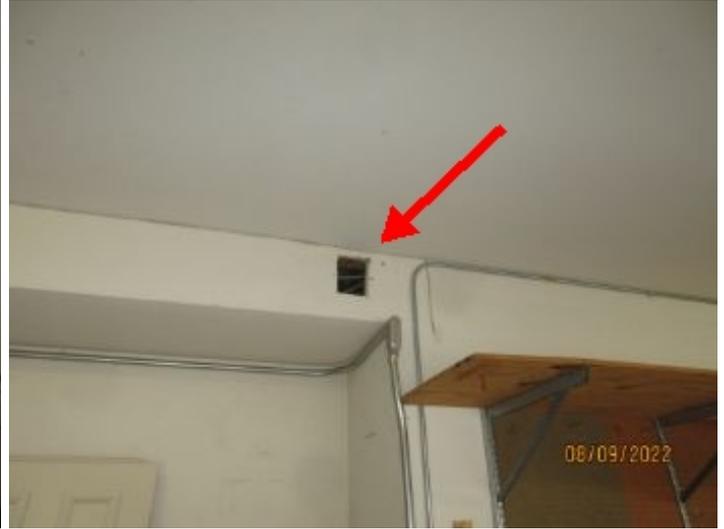
Hole noted in garage wall leading to interior of home. Recommend proper repair by a qualified contractor. (Fire hazard)

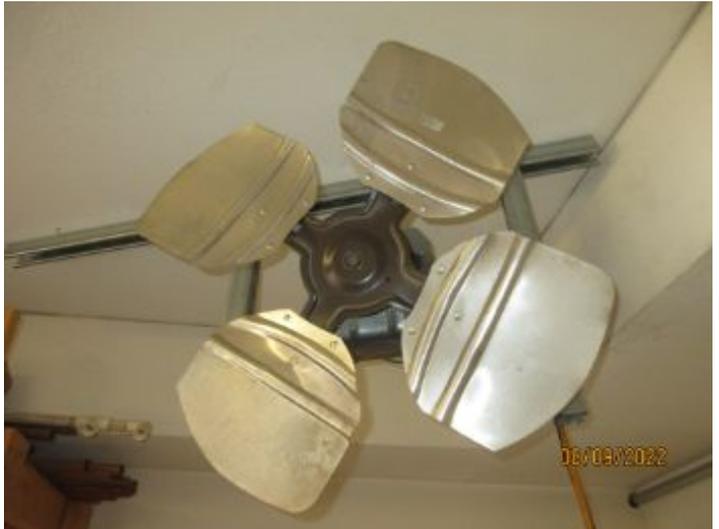
Recommend removing dangerous, non-protected fan in garage.

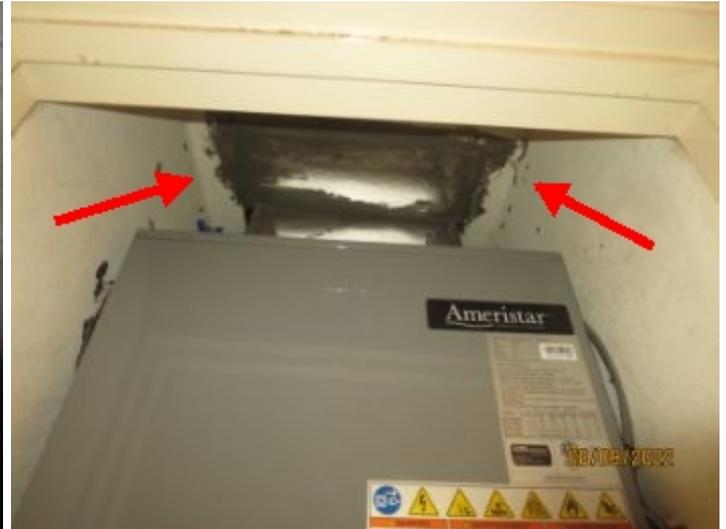
Recommend sealing attic openings by duct work in 2nd floor furnace closet.

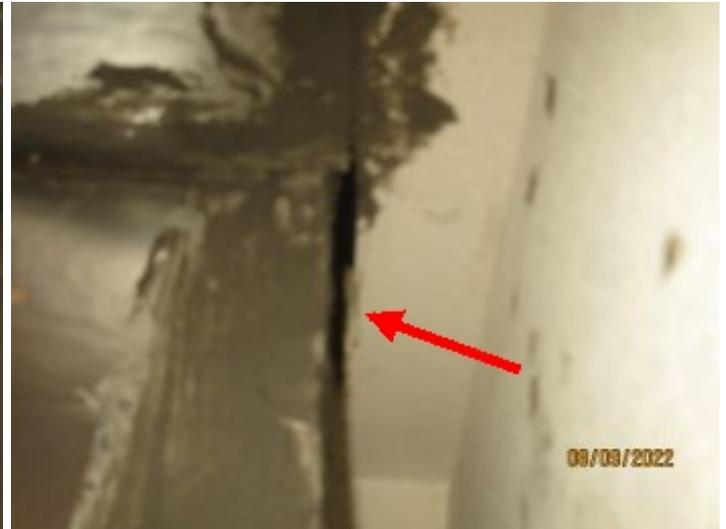
Recommend sealing attic openings by duct work in 2nd floor furnace closet.

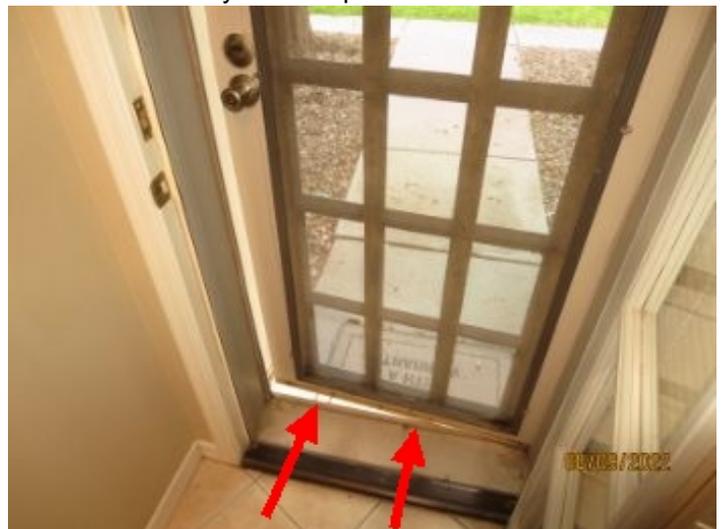
West hallway security door stick at threshold - very difficult to close and latch. Recommend review/repair by a qualified door contractor.

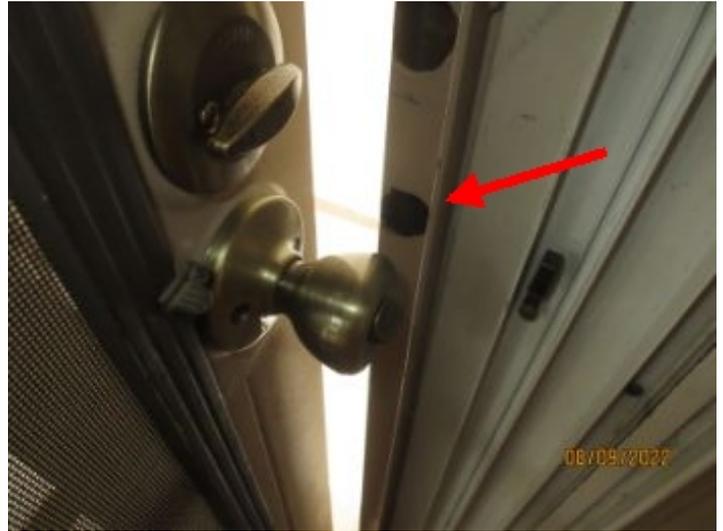
West hallway security door stick at threshold - very difficult to close and latch. Recommend review/repair by a qualified door contractor. Door knob would not latch at security door at back of house.

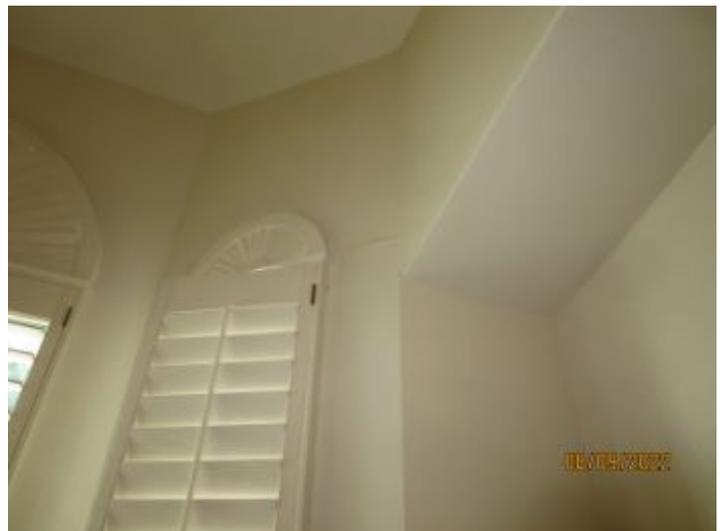
Possible water damage noted above west window on south wall of living room. The wall was dry at the time of inspection.

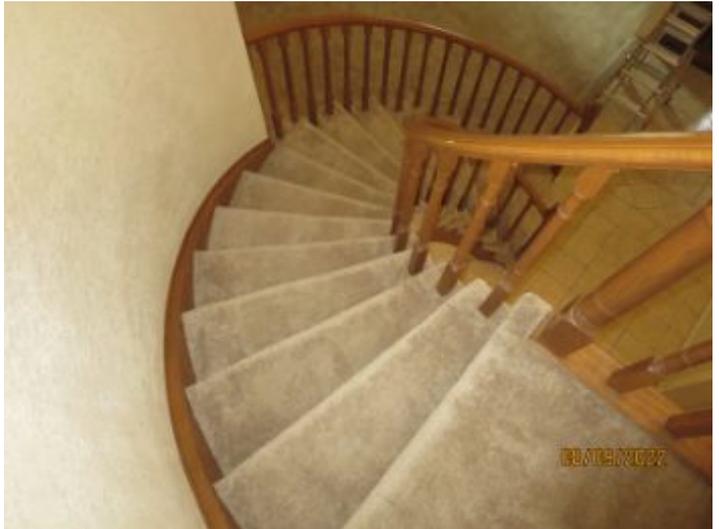
Current building standards allow a maximum of 4 inches between spindle spacing. This may not have been the standard when this home was built. Possible safety hazard to small children falling through openings and/or getting their heads stuck between spindles. Recommend upgrades to enhance safety of occupants and guests.

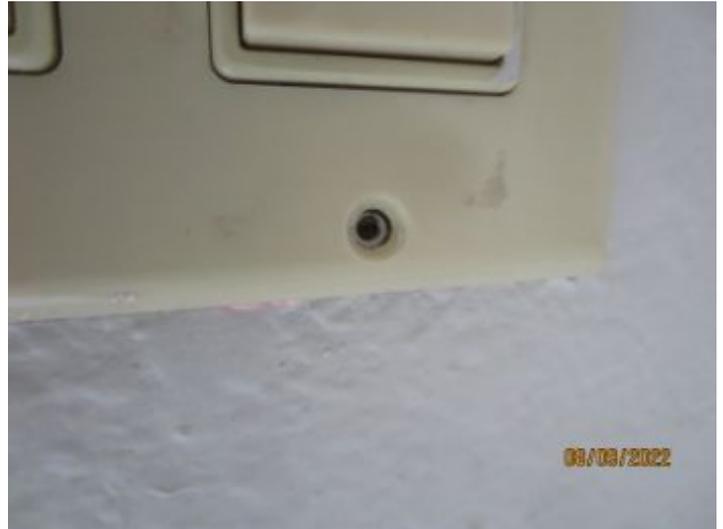
Cracked outlet/switch covers, missing screws noted in one or more location(s)

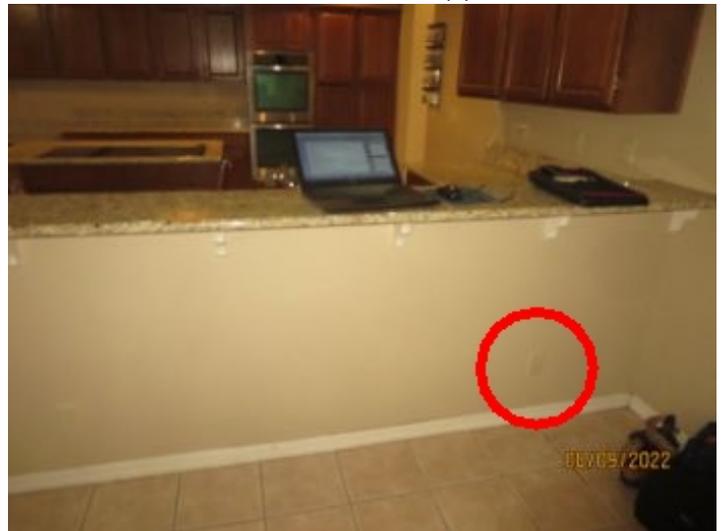
Top plug on the south outlet on the west side of the kitchen sink counter appeared to have a short in it when tested. Recommend further review/repair by a qualified electrician.

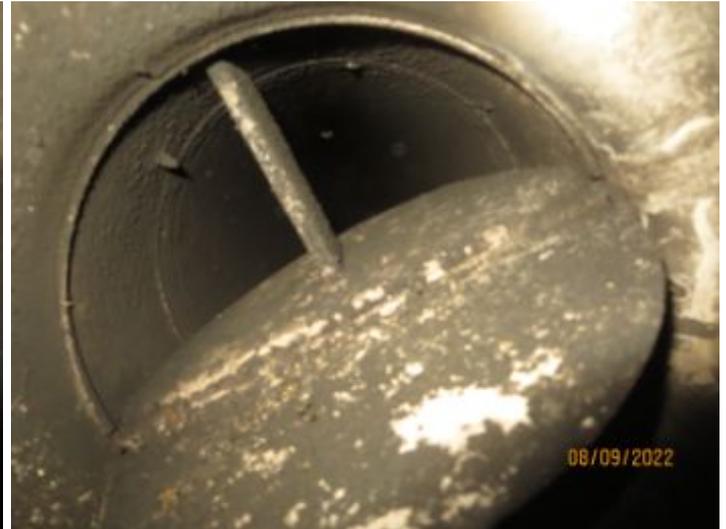
Creosote build up was observed and is considered highly flammable. Recommend hiring a chimney sweep to clean flue before operating fireplace/stove.

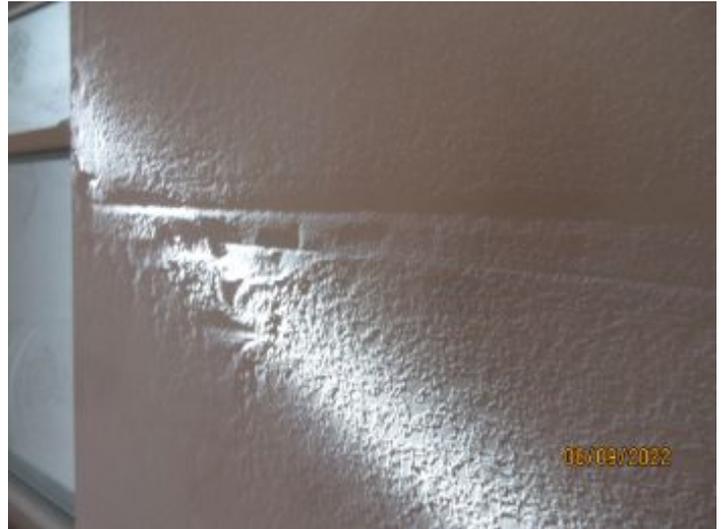
Evidence of water leak/damage noted to west wall next to south window in master bedroom. Moisture meter indicated high levels of moisture at drywall at the time of inspection. Recommend further review/repair by a qualified roofing contractor.

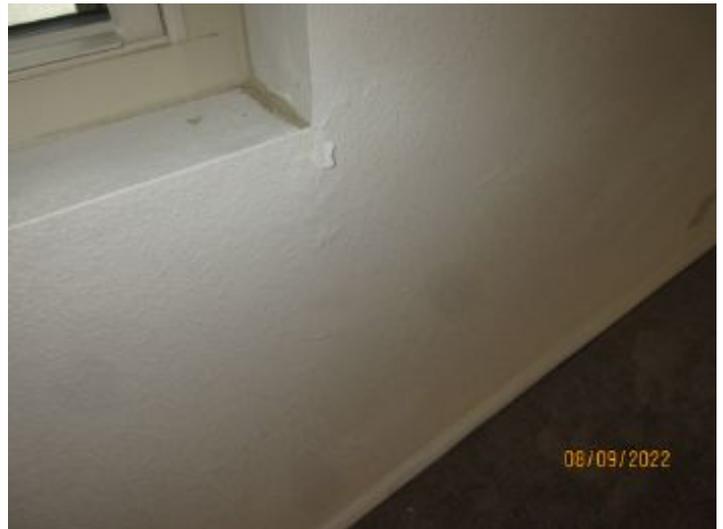
Evidence of water leak/damage noted to west wall next to south window in master bedroom. Moisture meter indicated high levels of moisture at drywall at the time of inspection. Recommend further review/repair by a qualified roofing contractor.

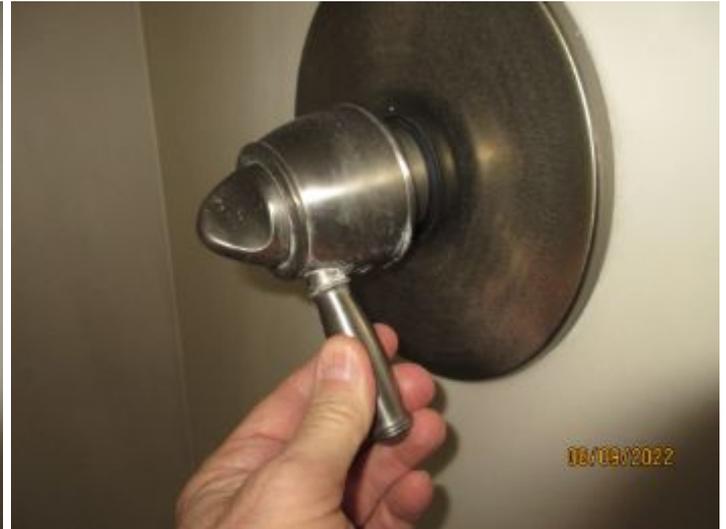
Minimal temperature difference noted at master bath shower between hot and cold. In addition, the master shower faucet handle was difficult to operate. Recommend further review/repair by a qualified plumbing contractor.

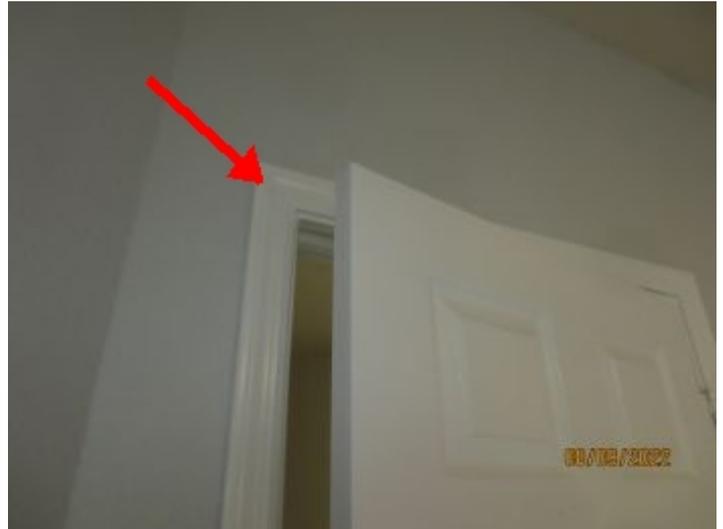
2nd floor west bedroom door sticks at the top jamb

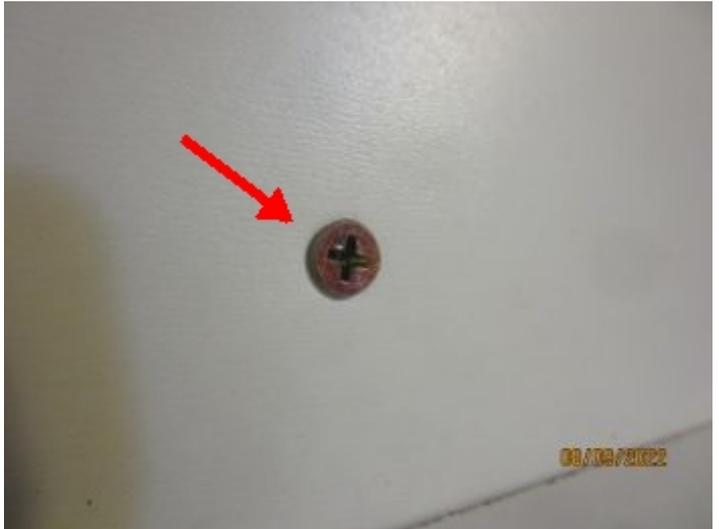
It appears that the cabinets in the 2nd floor northwest bedroom are attached with drywall screws. Recommend securing cabinets with proper cabinet fasteners to enhance safety of occupants and guests.

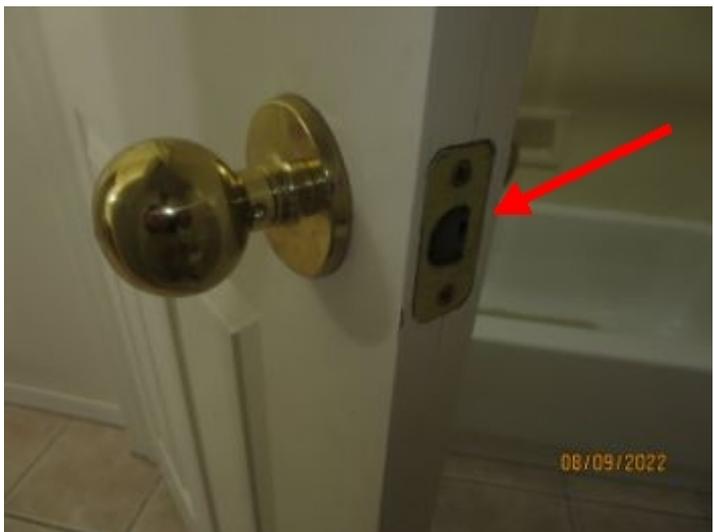
Damaged door knob hardware noted in 2nd floor guest bath.

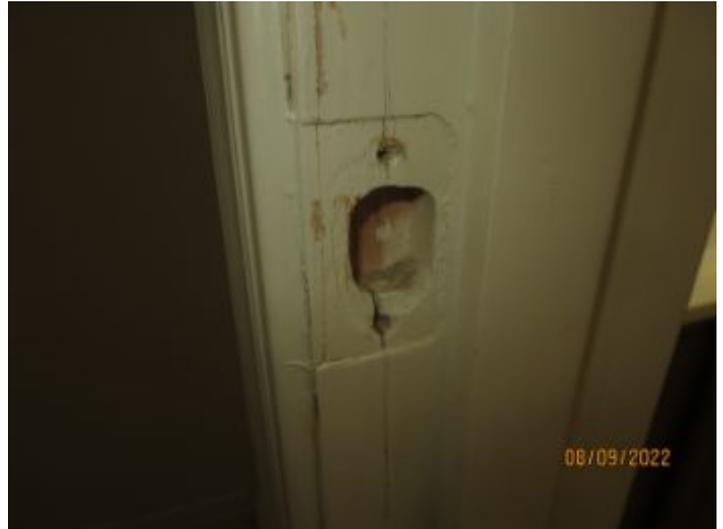
Damage/repair noted at door jamb in 2nd floor guest bath. Damage/repair noted at door jamb in 2nd floor guest bath.

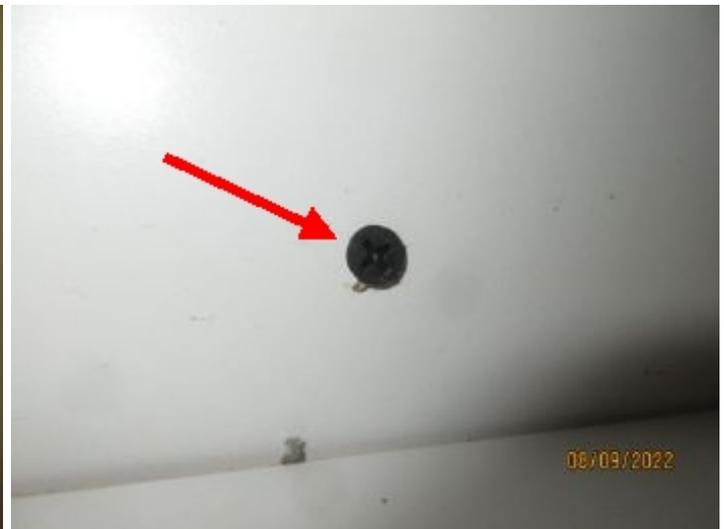
It appears that the cabinets in the laundry room are attached with drywall screws. Recommend securing cabinets with proper cabinet fasteners to enhance safety of occupants and guests.

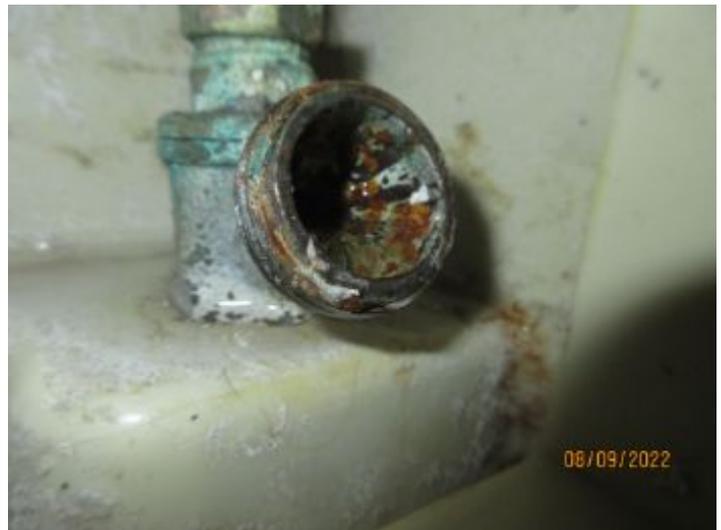
Drips/corrosion noted at both the hot and cold water shutoffs in the laundry room. Recommend further review/repair by a qualified plumbing contractor.

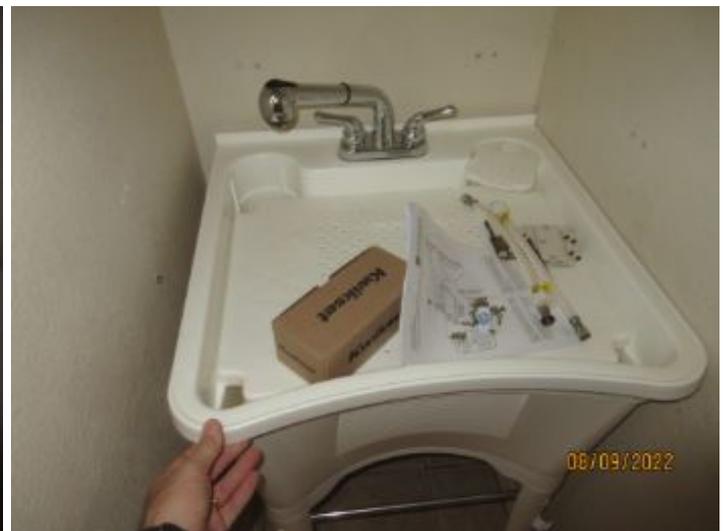
Recommend securing utility sink to wall in laundry room to prevent potential damage to future plumbing.

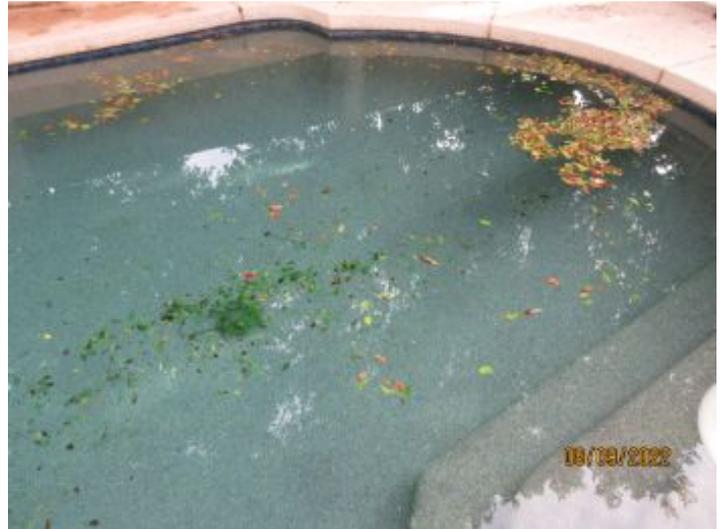
Leaves/dirty areas noted on bottom of pool at the time of inspection.

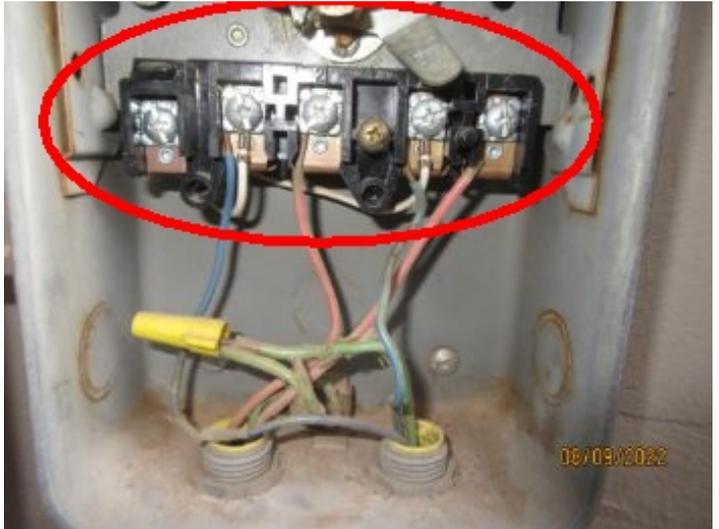
Timer missing plastic safety cover. Recommend replacement to enhance safety of occupants.
